DEPARTMENT OF TRANSPORTATION

Contract #: 04-0120F4Cty: SF/ALA Rte: 80 PM: 13.2/13.9File #: 69.28**WELDING INSPECTION REPORT****Resident Engineer:** Pursell, Gary**Address:** 333 Burma Road**City:** Oakland, CA 94607**Report No:** WIR-012703**Date Inspected:** 16-Mar-2010**Project Name:** SAS Superstructure**OSM Arrival Time:** 700**Prime Contractor:** American Bridge/Fluor Enterprises, a JV**OSM Departure Time:** 1900**Contractor:** Zhenhua Port Machinery Company, Ltd (ZPMC), Changxing Island **Location:** Shanghai, China**CWI Name:****CWI Present:**

Bridge No: 34-0006**Component:** OBG Trial Assembly**Summary of Items Observed:**

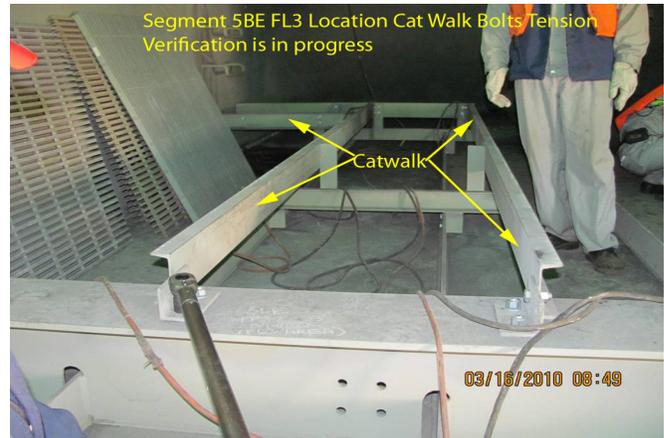
This Quality Assurance (QA) Inspector witnessed final tension verification for Bolts Installed at Segment 5BE at FL3 area at PP 32 and PP 33. Inspected 10% on a random basis and found the Rotation of Nut to be in general compliance. Inspection was performed against the Notification No. 00284 Dated March 16, 2010.
