DEPARTMENT OF TRANSPORTATION

Contract #: 04-0120F4Cty: SF/ALA Rte: 80 PM: 13.2/13.9File #: 69.28**WELDING INSPECTION REPORT****Resident Engineer:** Pursell, Gary**Address:** 333 Burma Road**City:** Oakland, CA 94607**Report No:** WIR-012886**Date Inspected:** 03-Apr-2010**Project Name:** SAS Superstructure**OSM Arrival Time:** 700**Prime Contractor:** American Bridge/Fluor Enterprises, a JV**OSM Departure Time:** 1900**Contractor:** Zhenhua Port Machinery Company, Ltd (ZPMC), Changxing Island **Location:** Shanghai, China**CWI Name:** Li Yang**CWI Present:** Yes No**Inspected CWI report:** Yes No N/A**Rod Oven in Use:** Yes No N/A**Electrode to specification:** Yes No N/A**Weld Procedures Followed:** Yes No N/A**Qualified Welders:** Yes No N/A**Verified Joint Fit-up:** Yes No N/A**Approved Drawings:** Yes No N/A**Approved WPS:** Yes No N/A**Delayed / Cancelled:** Yes No N/A**Bridge No:** 34-0006**Component:** OBG**Summary of Items Observed:**

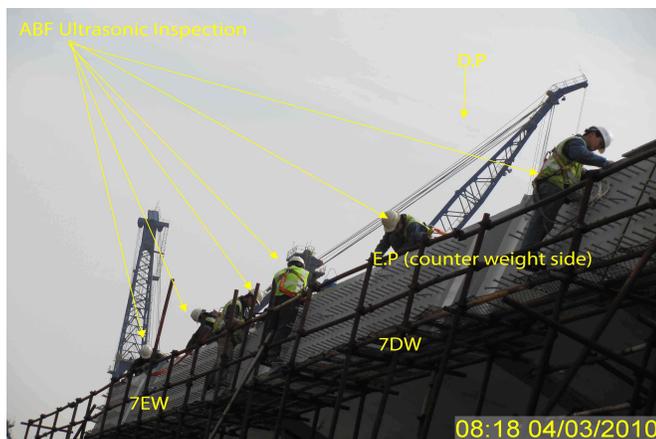
This Quality Assurance (QA) Inspector observed ABF QA Inspector performing Ultrasonic inspection on the weld between deck panel and edge panel (counter weight side) of OBG segment 7DW and 7EW.
