DEPARTMENT OF TRANSPORTATION

Contract #: 04-0120F4Cty: SF/ALA Rte: 80 PM: 13.2/13.9File #: 69.28**WELDING INSPECTION REPORT****Resident Engineer:** Pursell, Gary**Address:** 333 Burma Road**City:** Oakland, CA 94607**Report No:** WIR-013023**Date Inspected:** 09-Apr-2010**Project Name:** SAS Superstructure**OSM Arrival Time:** 1900**Prime Contractor:** American Bridge/Fluor Enterprises, a JV**OSM Departure Time:** 700**Contractor:** Zhenhua Port Machinery Company, Ltd (ZPMC), Changxing Island **Location:** Shanghai, China

On this date CALTRANS OSM Quality Assurance (QA) Inspector, Mr. Paul Dawson, arrived on site at the Zhenhua Port Machinery Company (ZPMC) facility at Changxing Island, in Shanghai, China, for the purpose of monitoring welding and fabrication of the San Francisco / Oakland Bay Bridge (SFOBB) components. This QA Inspector observed the following:

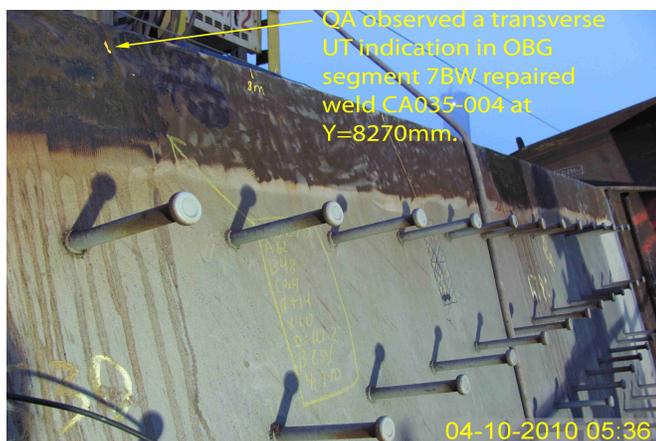
ABF issued "Inspection Notification Sheet" number 04082010-2 item #1 informing QA that on 4-09-2010 at 19:30 hours ABF Inspectors will be performing ultrasonic (UT) inspections of repaired weld CA035-004 which joins the deck plate and edge plate on the counterweight side of OBG segment 7BW. This weld is located in the OBG Segment Assembly yard. Caltrans QA Inspector Mr. Mike Hasler was informed by ABF/Sense UT Inspectors that ABF had located four UT rejections and the remainder of the weld repairs are UT acceptable. Mr. Mike Hasler performed ultrasonic inspections of weld repair locations #1 through #6 and this QA Inspector performed ultrasonic inspections from weld locations # 7 (Y=8125) through location #14 (Y=12110) as listed on the UT report data sheets for detection of longitudinal and planar transverse indications utilizing scanning patterns A, B, C and D (AWS D1.5 Fig 6.7). This QA Inspector observed ABF personnel have indicated locations Y=8530 and Y=9260 as being UT rejections and the remainder of these repair locations are UT acceptable. This QA Inspector observed a +14 transverse indication at Y=8270 and ABF had not marked this indication as being rejectable. The remainder of the repair locations appears to comply with project specifications. Note: These inspections are being documented and tracked on "Verification Witness Request" documents and no TL-6027 UT report or incident report was issued for these inspections. See the photograph below for additional information.
