**DEPARTMENT OF TRANSPORTATION**

Contract #: 04-0120F4Cty: SF/ALA Rte: 80 PM: 13.2/13.9File #: 69.28**WELDING INSPECTION REPORT****Resident Engineer:** Pursell, Gary**Address:** 333 Burma Road**City:** Oakland, CA 94607**Report No:** WIR-013267**Date Inspected:** 14-Apr-2010**Project Name:** SAS Superstructure**OSM Arrival Time:** 700**Prime Contractor:** American Bridge/Fluor Enterprises, a JV**OSM Departure Time:** 1900**Contractor:** Zhenhua Port Machinery Company, Ltd (ZPMC), Changxing Island **Location:** Shanghai, China**CWI Name:** Du Zhi Qun**CWI Present:** Yes No**Inspected CWI report:** Yes No N/A**Rod Oven in Use:** Yes No N/A**Electrode to specification:** Yes No N/A**Weld Procedures Followed:** Yes No N/A**Qualified Welders:** Yes No N/A**Verified Joint Fit-up:** Yes No N/A**Approved Drawings:** Yes No N/A**Approved WPS:** Yes No N/A**Delayed / Cancelled:** Yes No N/A**Bridge No:** 34-0006**Component:** Tower**Summary of Items Observed:**

## WELDING INSPECTION REPORT

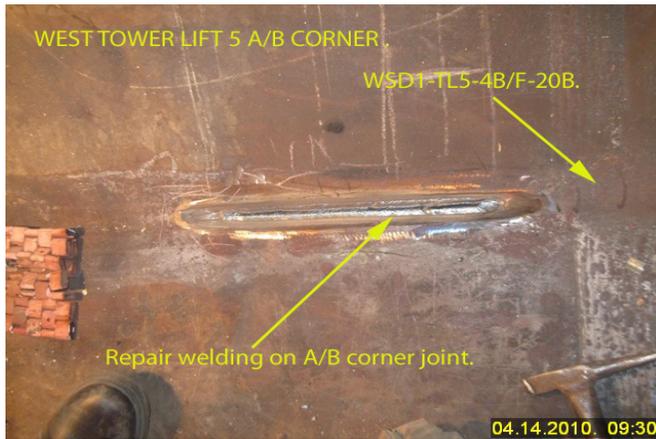
This QA Inspector observed ZPMC qualified welding personnel identified as 044541. Perform Shielded Metal Arc Welding (SMAW) on West Tower lift 5 A/B corner joint. Joint identified as WSD1-TL5-4B/F-20B, ZPMC QC Identified as Libin, with temporary welding repair report, The welding parameters as measured using QC's calibrated instrument appeared to be in general compliance with WPS-485-SMAW-1G (1F) Repair-1. For more information see below attach photo.
