DEPARTMENT OF TRANSPORTATION

Contract #: 04-0120F4Cty: SF/ALA Rte: 80 PM: 13.2/13.9File #: 69.28**WELDING INSPECTION REPORT****Resident Engineer:** Pursell, Gary**Address:** 333 Burma Road**City:** Oakland, CA 94607**Report No:** WIR-013629**Date Inspected:** 24-Apr-2010**Project Name:** SAS Superstructure**OSM Arrival Time:** 700**Prime Contractor:** American Bridge/Fluor Enterprises, a JV**OSM Departure Time:** 1900**Contractor:** Zhenhua Port Machinery Company, Ltd (ZPMC), Changxing Island **Location:** Shanghai, China**CWI Name:** Li Yang**CWI Present:** Yes No**Inspected CWI report:** Yes No N/A**Rod Oven in Use:** Yes No N/A**Electrode to specification:** Yes No N/A**Weld Procedures Followed:** Yes No N/A**Qualified Welders:** Yes No N/A**Verified Joint Fit-up:** Yes No N/A**Approved Drawings:** Yes No N/A**Approved WPS:** Yes No N/A**Delayed / Cancelled:** Yes No N/A**Bridge No:** 34-0006**Component:** OBG**Summary of Items Observed:**

WELDING INSPECTION REPORT

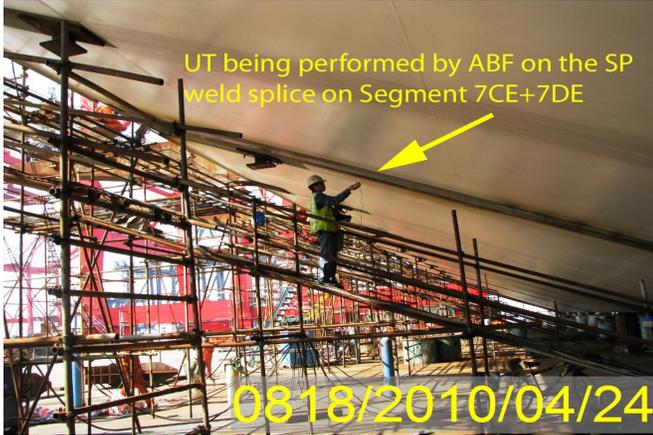
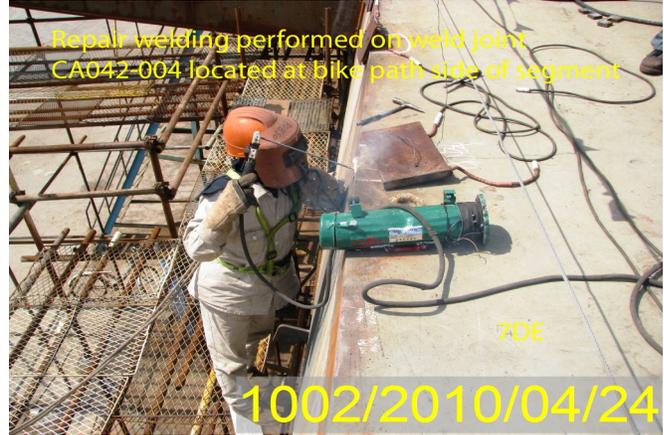
1. Side plate t stiffener hold back welds located on the bike path side of segment.

Unless otherwise noted, all work observed on this date appeared to generally comply with applicable contract documents.
