**DEPARTMENT OF TRANSPORTATION**

Contract #: 04-0120F4Cty: SF/ALA Rte: 80 PM: 13.2/13.9File #: 69.28**WELDING INSPECTION REPORT****Resident Engineer:** Pursell, Gary**Address:** 333 Burma Road**City:** Oakland, CA 94607**Report No:** WIR-013646**Date Inspected:** 25-Apr-2010**Project Name:** SAS Superstructure**OSM Arrival Time:** 1900**Prime Contractor:** American Bridge/Fluor Enterprises, a JV**OSM Departure Time:** 700**Contractor:** Zhenhua Port Machinery Company, Ltd (ZPMC), Changxing Island **Location:** Shanghai, China**CWI Name:** See Below**CWI Present:** Yes No**Inspected CWI report:** Yes No N/A**Rod Oven in Use:** Yes No N/A**Electrode to specification:** Yes No N/A**Weld Procedures Followed:** Yes No N/A**Qualified Welders:** Yes No N/A**Verified Joint Fit-up:** Yes No N/A**Approved Drawings:** Yes No N/A**Approved WPS:** Yes No N/A**Delayed / Cancelled:** Yes No N/A**Bridge No:** 34-0006**Component:** OBG**Summary of Items Observed:**

# WELDING INSPECTION REPORT

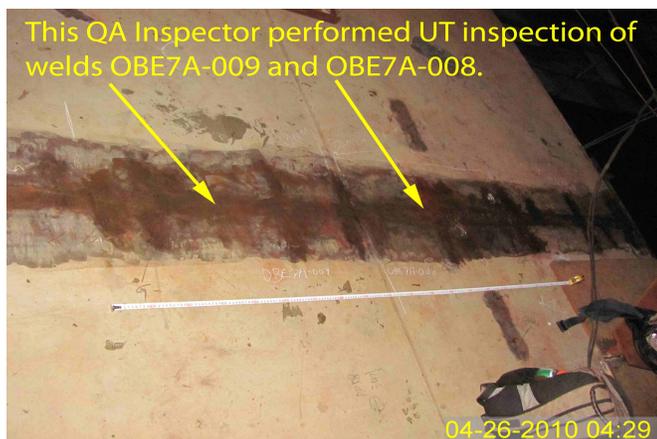
ABF issued UT inspection report number UT-7E-066 informing QA personnel that on 4-24-2010 Inspectors had completed ultrasonic (UT) inspections of OBG segment 7DE / 7EE welds OBE7A-007, OBE7A-008 and OBE7A-009 which join the top deck plates together. These welds are located at the Trial Assembly area. This QA Inspector observed ABF has identified weld rejections on weld OBE7A-007 at locations Y=1570mm, Y=1580mm and weld OBE7A-009 has one weld rejection at Y=1520mm. This QA Inspector performed ultrasonic inspections for detection of longitudinal and planar transverse indications utilizing scanning patterns A, B, C and D (AWS D1.5 Fig 6.7) of approximately one meter length of each of the three welds listed above and no additional weld repair locations were observed. Note: These inspections are being documented and tracked on "Verification Witness Request" documents and no TL-6027 UT report was issued for these inspections. Note: Caltrans QA Inspector Mr. Mike Hasler also performed random ultrasonic inspections of weld OBE7A-008. See the photograph below for additional information.
