**DEPARTMENT OF TRANSPORTATION**

Contract #: 04-0120F4Cty: SF/ALA Rte: 80 PM: 13.2/13.9File #: 99.28**WELDING INSPECTION REPORT****Resident Engineer:** Pursell, Gary**Address:** 333 Burma Road**City:** Oakland, CA 94607**Report No:** WIR-013746**Date Inspected:** 01-May-2010**Project Name:** SAS Superstructure**OSM Arrival Time:** 700**Prime Contractor:** American Bridge/Fluor Enterprises, a JV**OSM Departure Time:** 1900**Contractor:** Zhenhua Port Machinery Company, Ltd (ZPMC) Chanxing Island**Location:** Shanghai, China**CWI Name:** N/A**CWI Present:** Yes No**Inspected CWI report:** Yes No N/A**Rod Oven in Use:** Yes No N/A**Electrode to specification:** Yes No N/A**Weld Procedures Followed:** Yes No N/A**Qualified Welders:** Yes No N/A**Verified Joint Fit-up:** Yes No N/A**Approved Drawings:** Yes No N/A**Approved WPS:** Yes No N/A**Delayed / Cancelled:** Yes No N/A**Bridge No:** 34-0006**Component:** OBG Segment 10CW**Summary of Items Observed:**

# WELDING INSPECTION REPORT

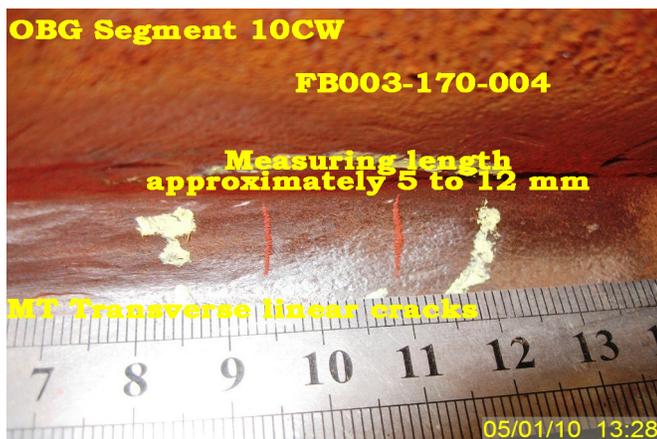
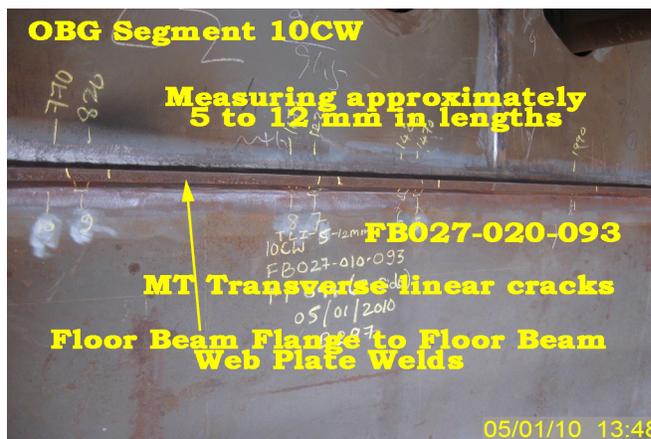
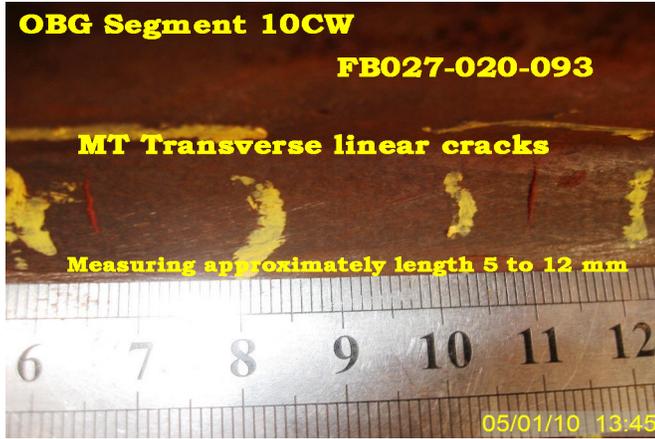
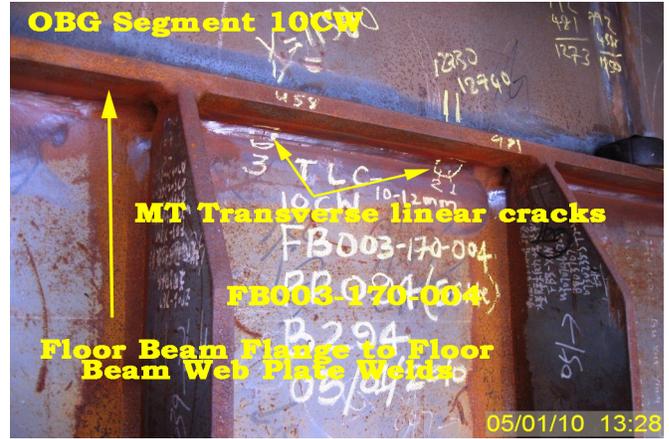
Description of Incident: During random Quality Assurance Visual review of welds located on segment 10CW, this Quality Assurance Inspector (QA) discovered three (3) Transverse linear indications measuring approximately 8 to 12mm in lengths. The indications were discovered visually and confirmed by Magnetic particle Testing (MT) by Caltrans QA. ZPMC Quality Control MT Technicians claimed that magnetic particle testing have been performed on these welds that require 25% MT. The indications are clearly marked on the material near the weld. The weld number is identified as FB003-170-004. The panel point is identified as a PP094. This weld is a Fillet weld joining the Floor beam Web to Flange. The Floor Beam Flange weld is identified as Non SPCM. For further information, please see the attached pictures
