**DEPARTMENT OF TRANSPORTATION**

Contract #: 04-0120F4Cty: SF/ALA Rte: 80 PM: 13.2/13.9File #: 69.28**WELDING INSPECTION REPORT****Resident Engineer:** Pursell, Gary**Address:** 333 Burma Road**City:** Oakland, CA 94607**Report No:** WIR-013931**Date Inspected:** 11-May-2010**Project Name:** SAS Superstructure**OSM Arrival Time:** 700**Prime Contractor:** American Bridge/Fluor Enterprises, a JV**OSM Departure Time:** 1900**Contractor:** Zhenhua Port Machinery Company, Ltd (ZPMC), Changxing Island **Location:** Shanghai, China

# WELDING INSPECTION REPORT

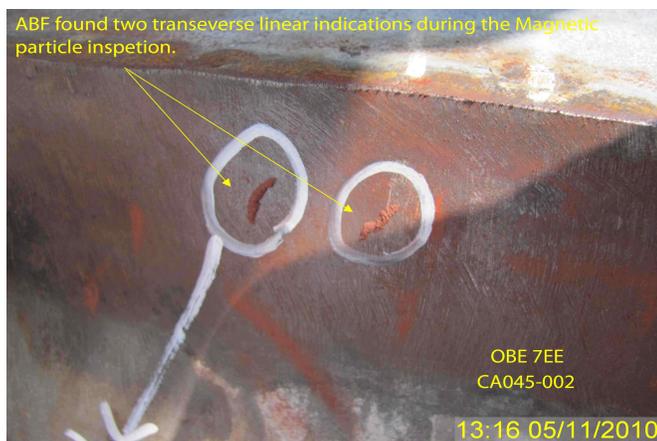
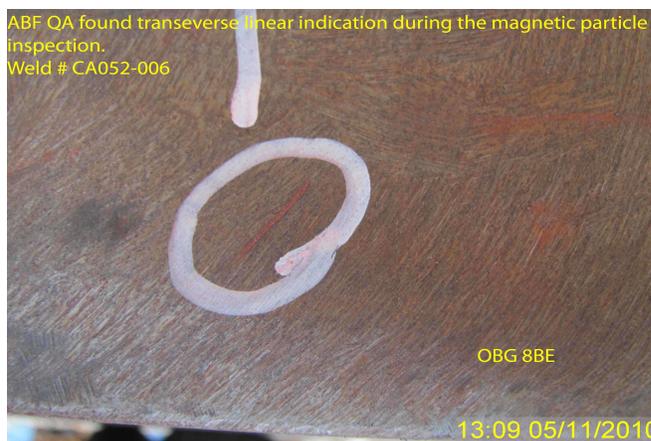
During the magnetic particle inspection ABF QA Inspector found five transverse linear indications.

During the magnetic particle inspection ABF QA Inspector found two transverse linear indications.
