DEPARTMENT OF TRANSPORTATION

Contract #: 04-0120F4Cty: SF/ALA Rte: 80 PM: 13.2/13.9File #: 69.28**WELDING INSPECTION REPORT****Resident Engineer:** Pursell, Gary**Address:** 333 Burma Road**City:** Oakland, CA 94607**Report No:** WIR-014299**Date Inspected:** 19-May-2010**Project Name:** SAS Superstructure**OSM Arrival Time:** 700**Prime Contractor:** American Bridge/Fluor Enterprises, a JV**OSM Departure Time:** 1900**Contractor:** Zhenhua Port Machinery Company, Ltd (ZPMC), Changxing Island **Location:** Shanghai, China

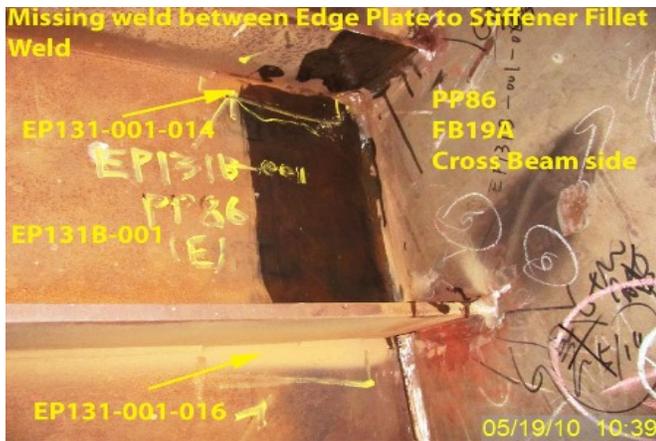
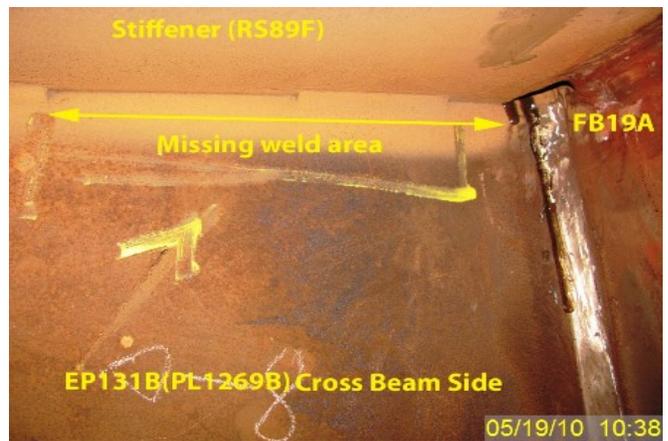
During Caltrans (CT) Quality Assurance random Visual Testing (VT) for segment tagging on Orthotropic Box Girder (OBG) segment 10AW, this Quality Assurance Inspector (QA) discovered the following issues that ZPMC appears to have failed to perform the required VT and Magnetic particle Testing (MT) of hold back area of the fillet weld joints joining two of the stiffeners to the edge plate near Panel Point (PP) 086 on the east side of this

panel point between W5 and W6 line. The weld joints are identified as EP131-001-013 and EP131-001-015. The joints have not yet been welded. According to the approved shop drawings 6mm fillet weld required. ZPMC has released OBG segment 10AW to CT to perform segment tag NDT. According to the contract documents ZPMC is required to perform 100% VT and MT of these joints. The Edge panel is designated on the approved shop drawings as Seismic Performance Critical Member (SPCM). The Edge plate is identified as PL1269B (SPCM) and both stiffeners are identified as RS89F. The missing welds are approximately 250 mm in length from panel point PP86. OBG Segment 10AW is located back side of Bay#16.
