**DEPARTMENT OF TRANSPORTATION**

Contract #: 04-0120F4Cty: SF/ALA Rte: 80 PM: 13.2/13.9File #: 69.28**WELDING INSPECTION REPORT****Resident Engineer:** Pursell, Gary**Address:** 333 Burma Road**City:** Oakland, CA 94607**Report No:** WIR-014397**Date Inspected:** 19-May-2010**Project Name:** SAS Superstructure**OSM Arrival Time:** 700**Prime Contractor:** American Bridge/Fluor Enterprises, a JV**OSM Departure Time:** 1900**Contractor:** Zhenhua Port Machinery Company, Ltd (ZPMC), Changxing Island **Location:** Shanghai, China**CWI Name:** Mr. Zhao Chen Sun/Qiu wen**CWI Present:** Yes No**Inspected CWI report:** Yes No N/A**Rod Oven in Use:** Yes No N/A**Electrode to specification:** Yes No N/A**Weld Procedures Followed:** Yes No N/A**Qualified Welders:** Yes No N/A**Verified Joint Fit-up:** Yes No N/A**Approved Drawings:** Yes No N/A**Approved WPS:** Yes No N/A**Delayed / Cancelled:** Yes No N/A**Bridge No:** 34-0006**Component:** Tower**Summary of Items Observed:**

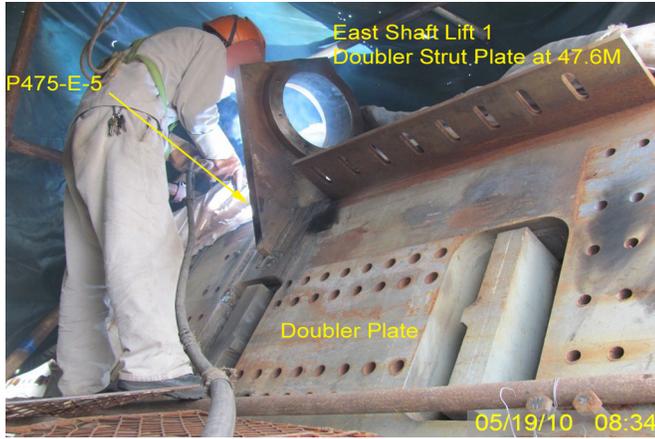
FCAW welding of weld joint no: P475-E-5 located on East Shaft Lift 1 Doubler Strut Plate at 47.6M Elevation. Welder is identified as 053316.ZPMC CWI is identified as Mr.Zhao Chen Sun. The welding variables recorded by QC appeared to comply with the WPS-B-T-4331-TC-P4-F. See the attached photo.

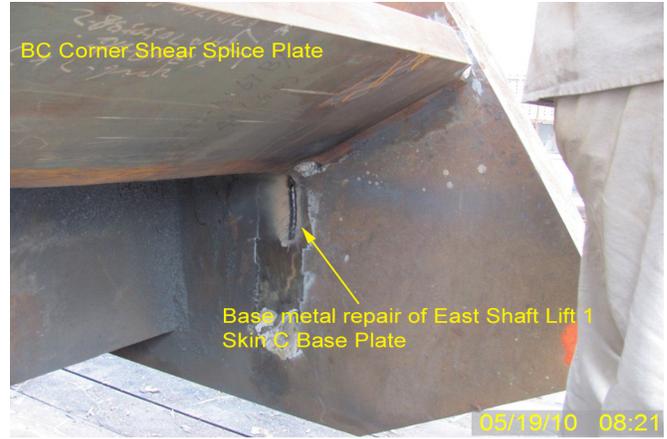
ZPMC performed Base metal repair of East Shaft Lift 1 located on Skin C Base Plate. The base metal repair area is approximately 3mm depth and 150mm length .Welder is identified as 040675.ZPMC QC is identified as Mr.Zhu Feng. SMAW welding was been performed against Temporary weld repair report. The welding variables recorded by QC appeared to comply with the WPS-345-SMAW-3G(3F)-Repair. See the attached photo.
