**DEPARTMENT OF TRANSPORTATION**

Contract #: 04-0120F4Cty: SF/ALA Rte: 80 PM: 13.2/13.9File #: 69.28**WELDING INSPECTION REPORT****Resident Engineer:** Pursell, Gary**Address:** 333 Burma Road**City:** Oakland, CA 94607**Report No:** WIR-014398**Date Inspected:** 20-May-2010**Project Name:** SAS Superstructure**OSM Arrival Time:** 700**Prime Contractor:** American Bridge/Fluor Enterprises, a JV**OSM Departure Time:** 1900**Contractor:** Zhenhua Port Machinery Company, Ltd (ZPMC), Changxing Island **Location:** Shanghai, China**CWI Name:** Mr. Zhao Chen Sun**CWI Present:** Yes No**Inspected CWI report:** Yes No N/A**Rod Oven in Use:** Yes No N/A**Electrode to specification:** Yes No N/A**Weld Procedures Followed:** Yes No N/A**Qualified Welders:** Yes No N/A**Verified Joint Fit-up:** Yes No N/A**Approved Drawings:** Yes No N/A**Approved WPS:** Yes No N/A**Delayed / Cancelled:** Yes No N/A**Bridge No:** 34-0006**Component:** Tower**Summary of Items Observed:**

## WELDING INSPECTION REPORT

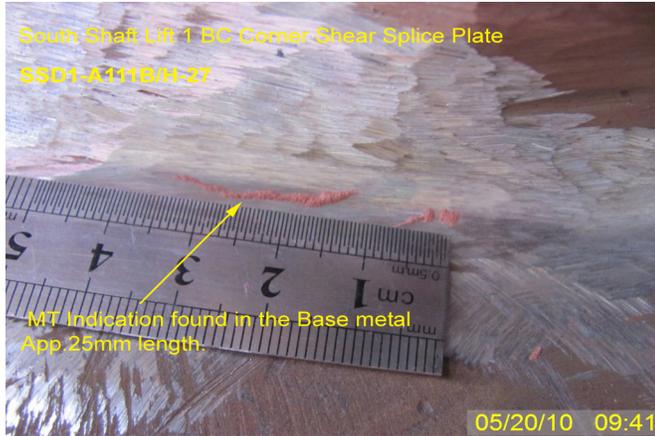
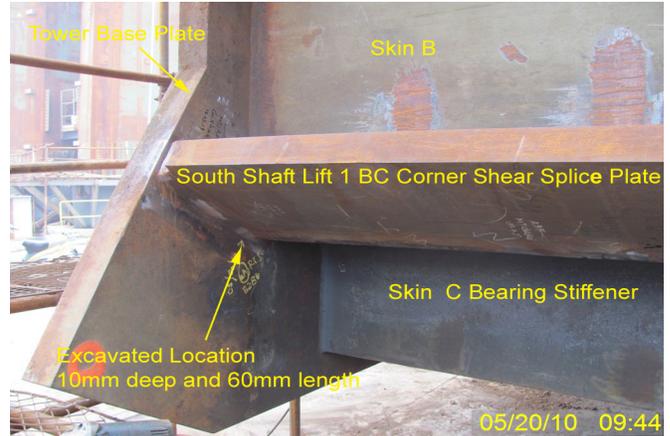
During random verification visual and MT inspection at South Shaft Lift 1 BC Corner Shear Splice Plate.

This Caltrans Quality Assurance (QA) Inspector discovered app.25mm length linear indication found in the Base metal and ZPMC excavated app.10mm deep and 60mm length to remove. The weld designated as #SSD1-A111B/H-27. This Shear Splice Plate has been VT, MT tested and accepted by ZPMC Quality Control personnel. The NDT Inspection Notification was issued and the Notification number is:005774. Incident report for the same has been raised. For further information, please see the attached pictures

The incident report is issued for the above mentioned discrepancy observed in Tower Trail Assembly and prior to issue it was informed to ZPMC QC and ABF QA.
