**DEPARTMENT OF TRANSPORTATION**

Contract #: 04-0120F4Cty: SF/ALA Rte: 80 PM: 13.2/13.9File #: 69.28**WELDING INSPECTION REPORT****Resident Engineer:** Pursell, Gary**Address:** 333 Burma Road**City:** Oakland, CA 94607**Report No:** WIR-014601**Date Inspected:** 05-Jun-2010**Project Name:** SAS Superstructure**OSM Arrival Time:** 700**Prime Contractor:** American Bridge/Fluor Enterprises, a JV**OSM Departure Time:** 1900**Contractor:** Zhenhua Port Machinery Company, Ltd (ZPMC), Changxing Island **Location:** Shanghai, China**CWI Name:** Guo Yan Fei**CWI Present:** Yes No**Inspected CWI report:** Yes No N/A**Rod Oven in Use:** Yes No N/A**Electrode to specification:** Yes No N/A**Weld Procedures Followed:** Yes No N/A**Qualified Welders:** Yes No N/A**Verified Joint Fit-up:** Yes No N/A**Approved Drawings:** Yes No N/A**Approved WPS:** Yes No N/A**Delayed / Cancelled:** Yes No N/A**Bridge No:** 34-0006**Component:** OBG/Tower**Summary of Items Observed:**

OBG Bay 12, Deck Panel 13AE-DP3074-001

BAY 12, Tower Facade Plate (ED1-A148-1)

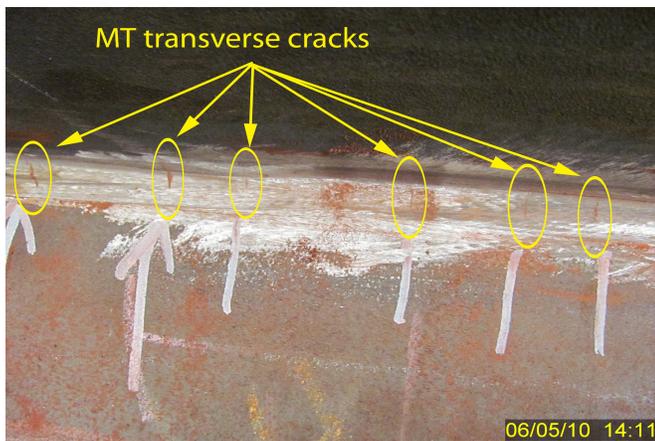
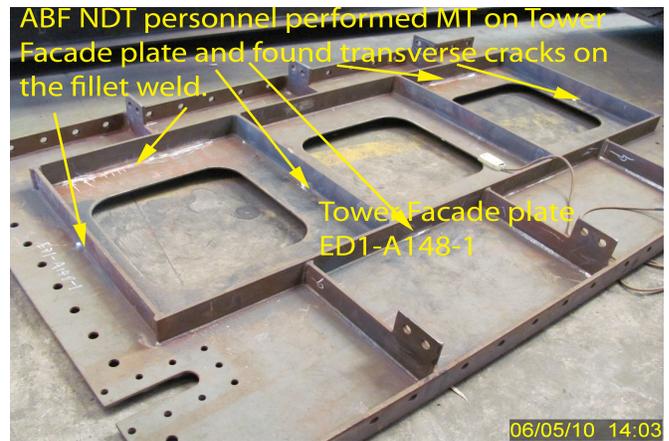
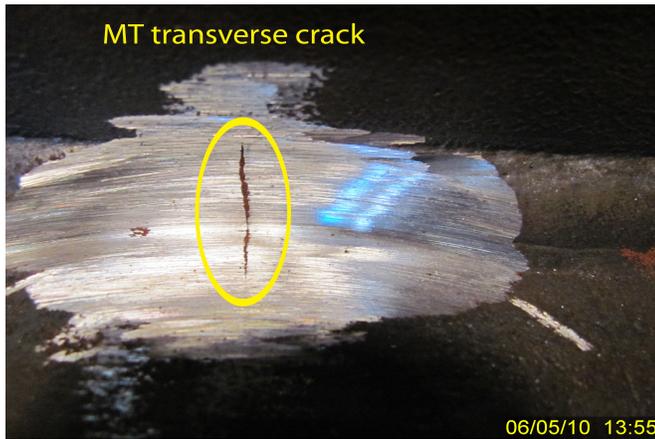
During random in process Visual inspection, this QA Inspector observed that ABF NDT personnel were performing Magnetic Particle Testing (MT) on the fillet weld of Tower Facade plate ED1-A148-1. During MT inspection ABF MT personnel found transverse cracks on the fillet weld on various locations. All indications were marked on the job by ABF. Attached photographs provide additional details.
