DEPARTMENT OF TRANSPORTATION

Contract #: 04-0120F4Cty: SF/ALA Rte: 80 PM: 13.2/13.9File #: 69.28**WELDING INSPECTION REPORT****Resident Engineer:** Pursell, Gary**Address:** 333 Burma Road**City:** Oakland, CA 94607**Report No:** WIR-014842**Date Inspected:** 12-Jun-2010**Project Name:** SAS Superstructure**OSM Arrival Time:** 700**Prime Contractor:** American Bridge/Fluor Enterprises, a JV**OSM Departure Time:** 1900**Contractor:** Zhenhua Port Machinery Company, Ltd (ZPMC), Changxing Island **Location:** Shanghai, China**CWI Name:****CWI Present:**

Bridge No: 34-0006**Component:** OBG Trial Assembly**Summary of Items Observed:**

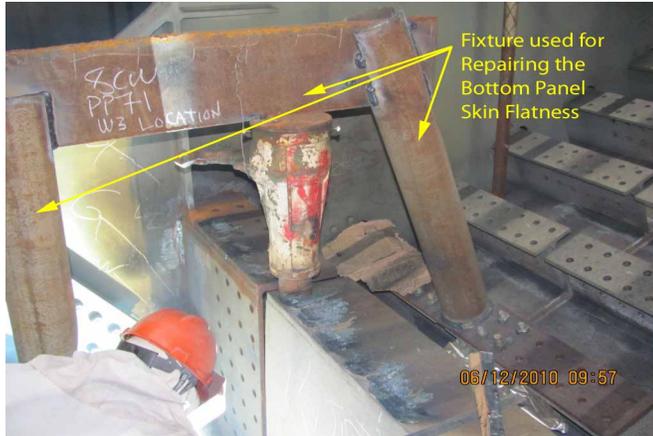
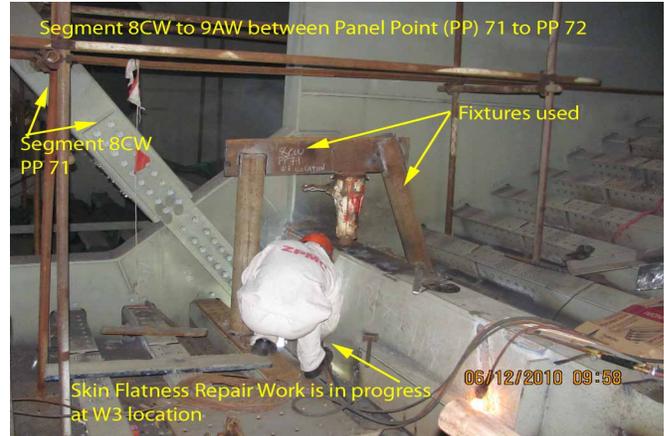
Segment 8CW to 9AW

This QA Inspector during random Inspection noticed Repair work was been performed by ZPMC personnel's for rectifying the Skin Flatness which is out by 13mm when measured with 5000mm String Line at Bottom Panel. The Repair work been performed at W3 locations against the Welding Repair Report B-WR13499 Rev. 0 between Panel Point (PP) 71 and PP 73 between Segment 8CW to 9AW. Please refer the pictures attached for more comprehensive details.
