DEPARTMENT OF TRANSPORTATION

Contract #: 04-0120F4Cty: SF/ALA Rte: 80 PM: 13.2/13.9File #: 69.28**WELDING INSPECTION REPORT****Resident Engineer:** Pursell, Gary**Address:** 333 Burma Road**City:** Oakland, CA 94607**Report No:** WIR-014950**Date Inspected:** 16-Jun-2010**Project Name:** SAS Superstructure**OSM Arrival Time:** 700**Prime Contractor:** American Bridge/Fluor Enterprises, a JV**OSM Departure Time:** 1900**Contractor:** Zhenhua Port Machinery Company, Ltd (ZPMC), Changxing Island **Location:** Shanghai, China**CWI Name:** An Qing Xiang.**CWI Present:** Yes No**Inspected CWI report:** Yes No N/A**Rod Oven in Use:** Yes No N/A**Electrode to specification:** Yes No N/A**Weld Procedures Followed:** Yes No N/A**Qualified Welders:** Yes No N/A**Verified Joint Fit-up:** Yes No N/A**Approved Drawings:** Yes No N/A**Approved WPS:** Yes No N/A**Delayed / Cancelled:** Yes No N/A**Bridge No:** 34-0006**Component:** Tower**Summary of Items Observed:**

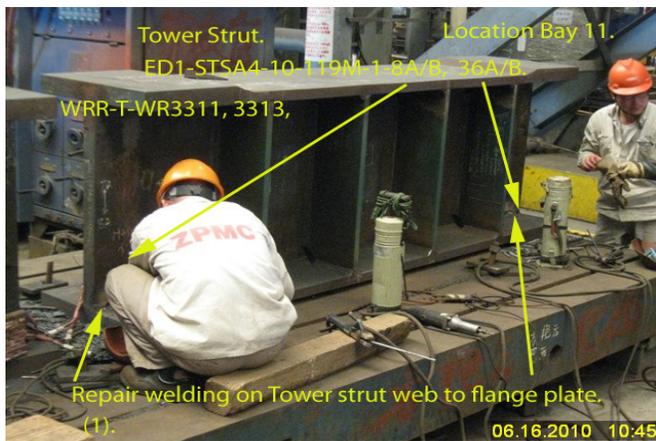
This QA Inspector observed ZPMC qualified welding personnel identified as 044551, Perform Shielded Metal Arc Welding (SMAW) on Tower strut. Joint identified as ED1-STSA4-10-119M-1-36A/B, ZPMC QC Identified as Liu Dao Feng, with temporary welding repair report WRR-T-WR3313. The welding parameters as measured using QC's calibrated instrument appeared to be in general compliance with WPS-485-SMAW-2G (2F)-FCM-Repair-1. For more information see below attach photo number 1.

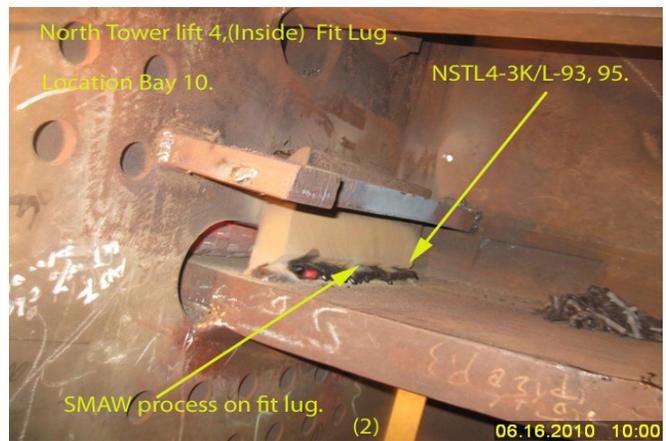
This QA Inspector observed ZPMC qualified welding personnel identified as 056364, Perform Shielded Metal Arc Welding (SMAW) on North tower lift 4 Fit Lug near 143M Double diaphragm. Joint identified as NSTL4-3K/L-93, 95. ZPMC QC Identified as Lijun, The welding parameters as measured using QC's calibrated instrument appeared to be in general compliance with WPS-B-T-2313-Tc-P4. For more information see below attach photo number 2.
