**DEPARTMENT OF TRANSPORTATION**

Contract #: 04-0120F4Cty: SF/ALA Rte: 80 PM: 13.2/13.9File #: 69.28**WELDING INSPECTION REPORT****Resident Engineer:** Pursell, Gary**Address:** 333 Burma Road**City:** Oakland, CA 94607**Report No:** WIR-015073**Date Inspected:** 16-Jun-2010**Project Name:** SAS Superstructure**OSM Arrival Time:** 700**Prime Contractor:** American Bridge/Fluor Enterprises, a JV**OSM Departure Time:** 1900**Contractor:** Zhenhua Port Machinery Company, Ltd (ZPMC), Changxing Island **Location:** Shanghai, China**CWI Name:****CWI Present:**

**Bridge No:** 34-0006**Component:** OBG Trial Assembly**Summary of Items Observed:**

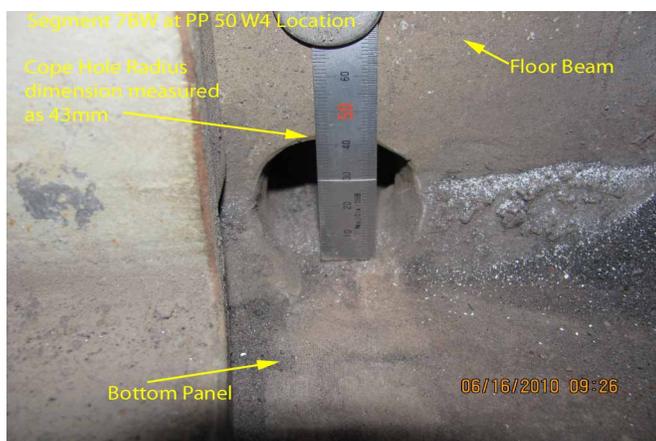
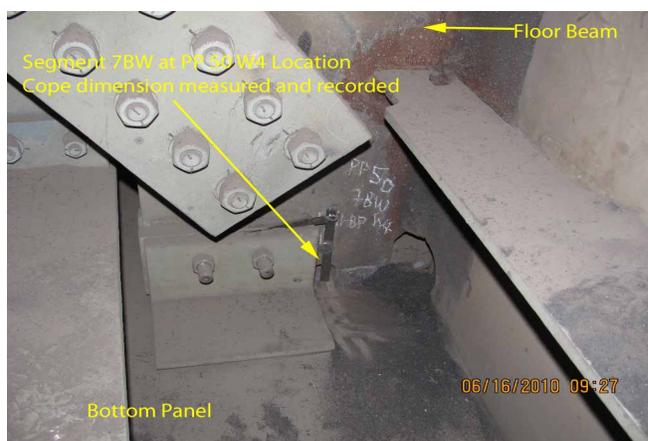
## Segment 7BW

This QA Inspector performed Dimension Control Inspection for the Cope Holes for Segment 7BW at Panel Point (PP) 50 Work Point W4 location and observed oversize cope hole at Bottom Panel to Floor beam. Please refer the attached pictures for more comprehensive details. The measured readings was recorded on Dimension Control Form and was submitted to the Lead and Engineer for review.
