DEPARTMENT OF TRANSPORTATION

Contract #: 04-0120F4Cty: SF/ALA Rte: 80 PM: 13.2/13.9File #: 69.28**WELDING INSPECTION REPORT****Resident Engineer:** Pursell, Gary**Address:** 333 Burma Road**City:** Oakland, CA 94607**Report No:** WIR-015128**Date Inspected:** 26-Jun-2010**Project Name:** SAS Superstructure**OSM Arrival Time:** 700**Prime Contractor:** American Bridge/Fluor Enterprises, a JV**OSM Departure Time:** 1900**Contractor:** Zhenhua Port Machinery Company, Ltd (ZPMC), Changxing Island **Location:** Shanghai, China**CWI Name:** Li Yang**CWI Present:** Yes No**Inspected CWI report:** Yes No N/A**Rod Oven in Use:** Yes No N/A**Electrode to specification:** Yes No N/A**Weld Procedures Followed:** Yes No N/A**Qualified Welders:** Yes No N/A**Verified Joint Fit-up:** Yes No N/A**Approved Drawings:** Yes No N/A**Approved WPS:** Yes No N/A**Delayed / Cancelled:** Yes No N/A**Bridge No:** 34-0006**Component:** OBG Segment**Summary of Items Observed:**

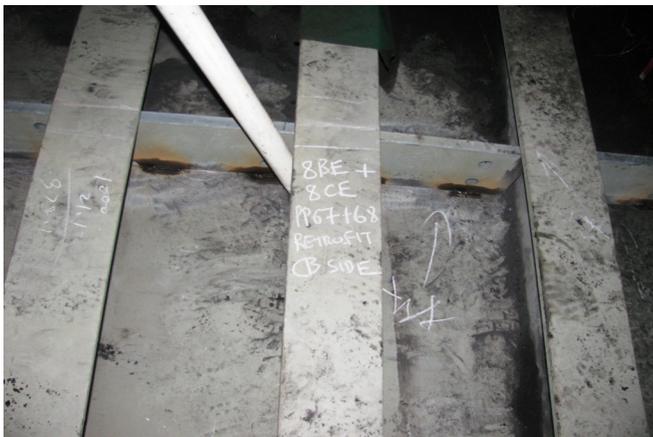
Welding of weld joint – 046 located on PCMK SEG048B, Longitudinal weld joints bottom and side panel of 8CE at E4 location between panel point 70 and 71. Welder is identified as 053253. Welding was been performed against critical welding repair report B-CWR1618. ZPMC CWI is identified as Wuzhi Cheng. The welding variables recorded by QC appeared to comply with the WPS-345-SMAW-4G (4F)-FCM-Repair-1.

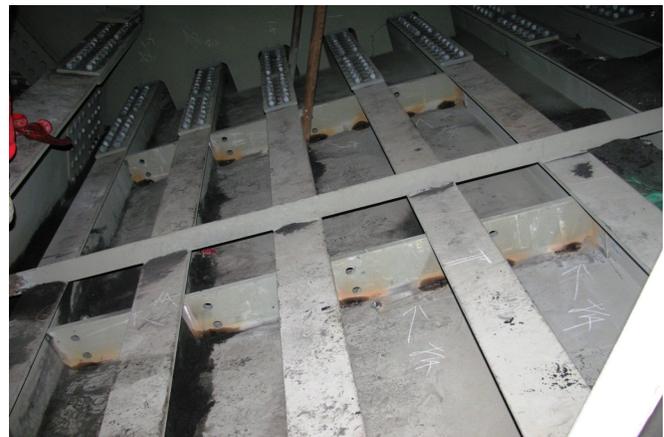
Welding of weld joint – 004 located on PCMK OBE9B, Side panel transverse splice weld joints segment 9AE and 9BE. Welder is identified as 053253. Welding was been performed against critical welding repair report B-CWR1592. ZPMC CWI is identified as Wuzhi Cheng. The welding variables recorded by QC appeared to comply with the WPS-345-SMAW-3G (3F)-FCM-Repair-1.
