Contract #: 04-0120F4Cty: SF/ALA Rte: 80 PM: 13.2/13.9File #: 69.28**WELDING INSPECTION REPORT****Resident Engineer:** Pursell, Gary**Address:** 333 Burma Road**City:** Oakland, CA 94607**Report No:** WIR-015215**Date Inspected:** 25-Jun-2010**Project Name:** SAS Superstructure**OSM Arrival Time:** 700**Prime Contractor:** American Bridge/Fluor Enterprises, a JV**OSM Departure Time:** 1900**Contractor:** Zhenhua Port Machinery Company, Ltd (ZPMC), Changxing Island **Location:** Shanghai, China**CWI Name:** Le Zhi Jiang**CWI Present:** Yes No**Inspected CWI report:** Yes No N/A**Rod Oven in Use:** Yes No N/A**Electrode to specification:** Yes No N/A**Weld Procedures Followed:** Yes No N/A**Qualified Welders:** Yes No N/A**Verified Joint Fit-up:** Yes No N/A**Approved Drawings:** Yes No N/A**Approved WPS:** Yes No N/A**Delayed / Cancelled:** Yes No N/A**Bridge No:** 34-0006**Component:** Orthotropic Box Girder (OBG)**Summary of Items Observed:**

OBG # CROSSBEAM CB13

WELDING INSPECTION REPORT

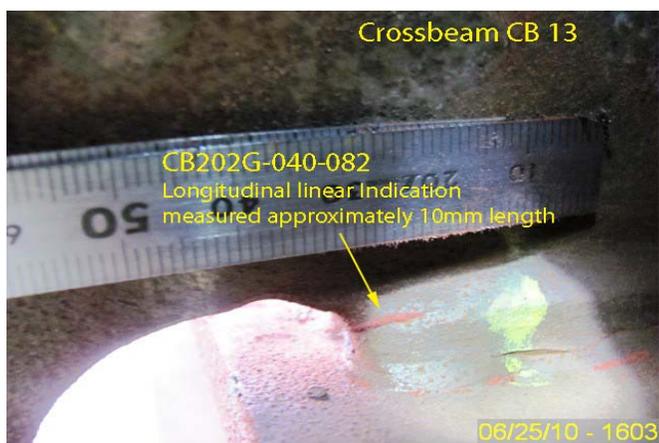
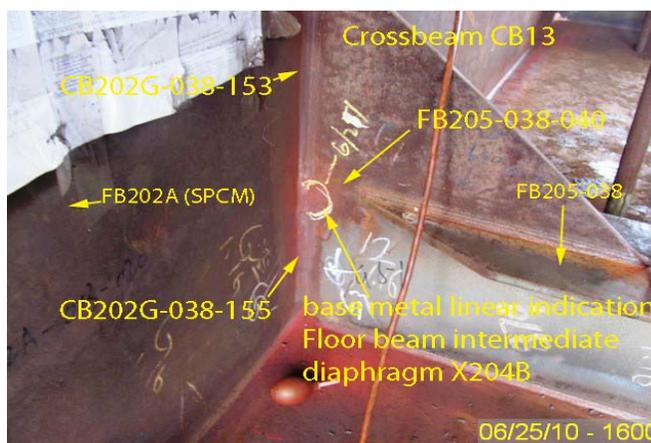
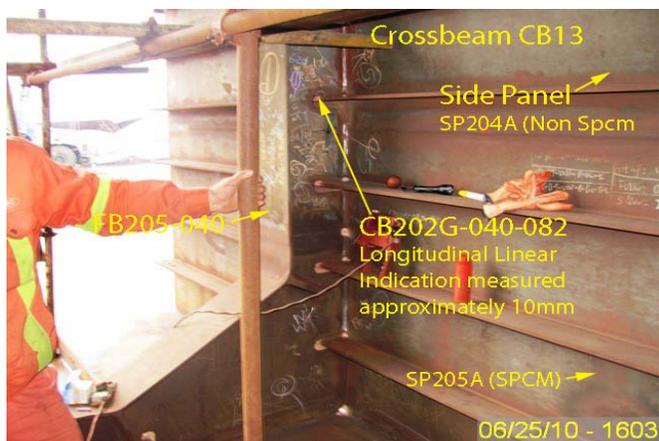
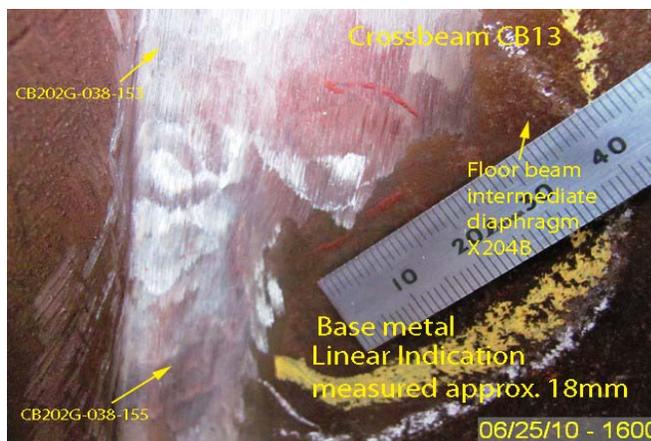
(CB202G-040-082) Non complaint Indication

(OBG) Cross Beam CB13, this Quality Assurance Inspector (QA) discovered the following issues. Two base metal linear indications measuring approximately 18mm and 15mm in length. One longitudinal crack indication measuring approximately 10mm in length. The base metal indications are located on floor beam diaphragm identified as FB205-038 adjacent to welds CB202G-038-153 & 155 (18 mm & 15mm). Welds CB202G-038-153 & 155 are Seismic Performance Critical Material (SPCM) fillet welds joining floor beam FB205-038 to intermediate web plate FB202A (SPCM). Y locations of these indications are approximately 350mm from the bottom panel. The crack indication is located in weld identified as CB202G-040-082. The weld is a fillet weld joining the side panel (SP204A) stiffener to the floor beam identified as FB205-040. Y location of this indication is 0mm. All indications are clearly marked on the material. This QA notified ZPMC QA identified as Mr. Zhang wei of this issue and that an incident report would be generated. For more information refer Magnetic particle Test report for this date. See attached picture.
