DEPARTMENT OF TRANSPORTATION

Contract #: 04-0120F4Cty: SF/ALA Rte: 80 PM: 13.2/13.9File #: 69.28**WELDING INSPECTION REPORT****Resident Engineer:** Pursell, Gary**Address:** 333 Burma Road**City:** Oakland, CA 94607**Report No:** WIR-015231**Date Inspected:** 06-Jun-2010**Project Name:** SAS Superstructure**OSM Arrival Time:** 700**Prime Contractor:** American Bridge/Fluor Enterprises, a JV**OSM Departure Time:** 1900**Contractor:** Zhenhua Port Machinery Company, Ltd (ZPMC), Changxing Island **Location:** Shanghai, China**CWI Name:** Le Zhi Jiang**CWI Present:** Yes No**Inspected CWI report:** Yes No N/A**Rod Oven in Use:** Yes No N/A**Electrode to specification:** Yes No N/A**Weld Procedures Followed:** Yes No N/A**Qualified Welders:** Yes No N/A**Verified Joint Fit-up:** Yes No N/A**Approved Drawings:** Yes No N/A**Approved WPS:** Yes No N/A**Delayed / Cancelled:** Yes No N/A**Bridge No:** 34-0006**Component:** Orthotropic Box Girder (OBG)**Summary of Items Observed:**

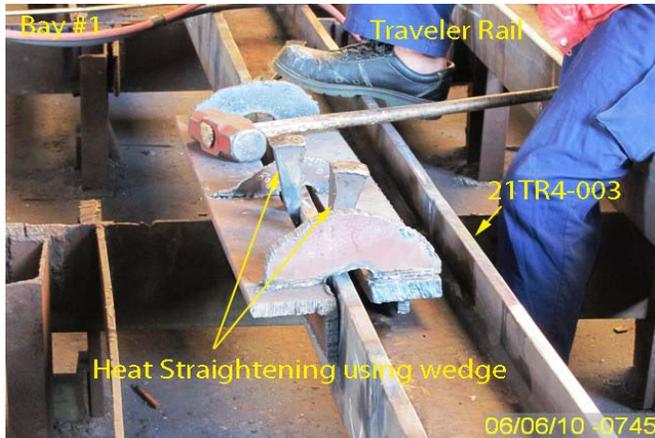
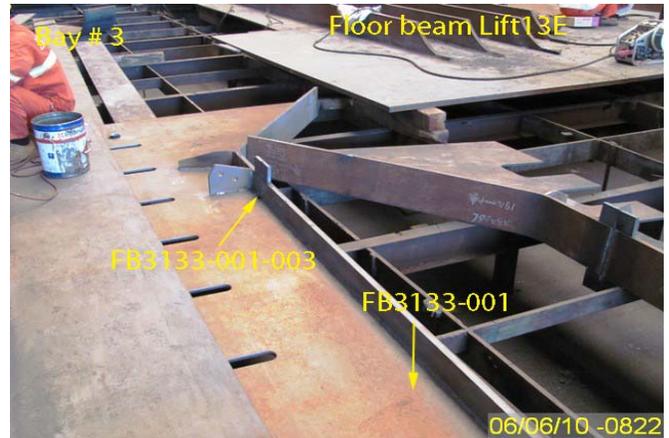
During the Quality Assurance (QA) random in-process visual inspection of Orthotropic Box Girder (OBG) Traveler Rails, this QA inspector discovered the following issues. ZPMC personnel performing heat straightening of 2 traveler rails. ZPMC did not appear to be following the approved heat straightening procedure HSR (B)-363, Revision 1. ZPMC personnel heated the areas to be straightened and mounted a temporary fixture to the flange and drove steel wedges between the fixture and flange. The use of the wedges is not mention in the approved HSR.

Furthermore, after the removal of the wedges and fixture, this QA observed damage to the base material of the flanges apparently caused by the steel wedges. The affected Traveler Rails are identified as: 21TR4-003, 21TR3-003. This QA notified ZPMC QA identified as Mr. Zhang wei of this issue and that an incident report would be generated. See attached picture.

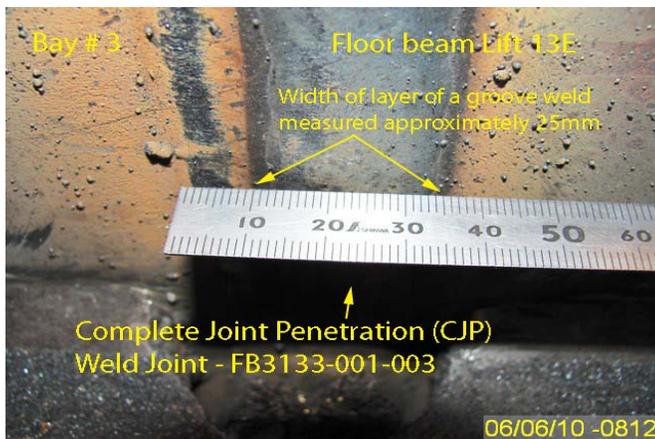
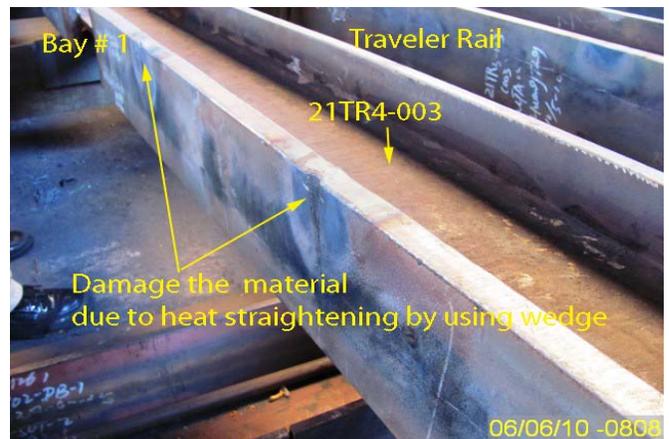
During the Quality Assurance (QA) random visual inspection of Orthotropic Box Girder (OBG) Floor beam Lift 13E, this Quality Assurance Inspector (QA) discovered the following issues. The width of a single weld pass was measured to be approximately 25mm. This welding was performed in the flat (1G) position. The welding process performed was Flux Cored Arc Welding (FCAW). The maximum FCAW single weld pass width allowed in this position is 16mm. The affected Floor beam is identified as: FB3133-001, FB3113-001 & FB3137-001. This weld is detailed as a Complete Joint Penetration (CJP) welds on approved drawing. The affected welds are identified as FB3133-001-003, FB3133-001-010, FB3113-001-001, FB3113-001-002, FB3137-001-003 and FB3137-001-010. This QA notified ZPMC QA identified as Mr. Zhang wei of this issue and that an incident report would be generated. See attached picture.
