DEPARTMENT OF TRANSPORTATION

Contract #: 04-0120F4Cty: SF/ALA Rte: 80 PM: 13.2/13.9File #: 69.28**WELDING INSPECTION REPORT****Resident Engineer:** Pursell, Gary**Address:** 333 Burma Road**City:** Oakland, CA 94607**Report No:** WIR-015240**Date Inspected:** 30-Jun-2010**Project Name:** SAS Superstructure**OSM Arrival Time:** 700**Prime Contractor:** American Bridge/Fluor Enterprises, a JV**OSM Departure Time:** 1900**Contractor:** Zhenhua Port Machinery Company, Ltd (ZPMC), Changxing Island **Location:** Shanghai, China**CWI Name:** Li Ming Yang**CWI Present:** Yes No**Inspected CWI report:** Yes No N/A**Rod Oven in Use:** Yes No N/A**Electrode to specification:** Yes No N/A**Weld Procedures Followed:** Yes No N/A**Qualified Welders:** Yes No N/A**Verified Joint Fit-up:** Yes No N/A**Approved Drawings:** Yes No N/A**Approved WPS:** Yes No N/A**Delayed / Cancelled:** Yes No N/A**Bridge No:** 34-0006**Component:** OBG Components**Summary of Items Observed:**

During random visual inspection of the suspender bracket in OBG fabricating bay#19, this QA inspector observed several discontinuities like under fill, notches, gouging marks and spatters at the cope hole locations. The locat

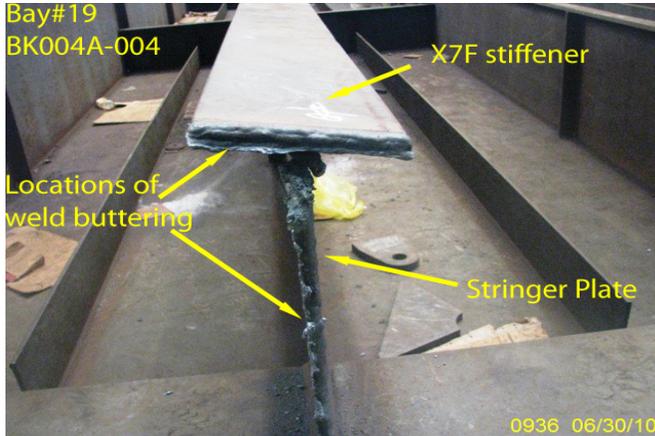
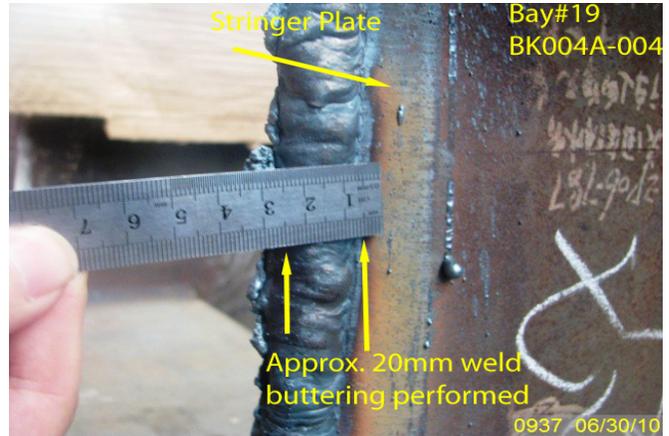
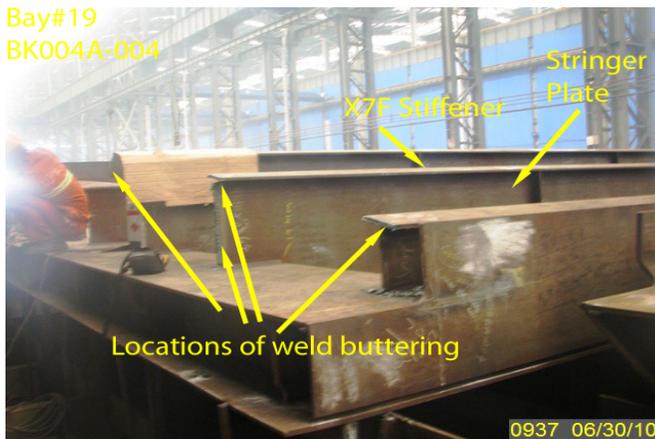
During random visual in process inspection of bike path, this QA inspector observed following issues:

This QA inspector observed weld buttering was performed by ZPMC personnel on the end of the stringer plates BKX8A, BKX8C, BKX9A, BKX9C and BKX10A and X7F stiffener.

The bike path is identified as BK004A-004.

According to the shop drawing the stringer plates length is 9202mm + 395mm bearing plate (both side).

The actual length of the stringer plates are 9~12mm short at east end.

ZPMC personnel will rectify the issues and will submit NWIT for visual inspection of the suspender brackets.

ZPMC personnel need to perform required NDT work after grinding on the weld buttering locations.
