Contract #: 04-0120F4Cty: SF/ALA Rte: 80 PM: 13.2/13.9File #: 69.28**WELDING INSPECTION REPORT****Resident Engineer:** Pursell, Gary**Address:** 333 Burma Road**City:** Oakland, CA 94607**Report No:** WIR-015263**Date Inspected:** 29-Jun-2010**Project Name:** SAS Superstructure**OSM Arrival Time:** 700**Prime Contractor:** American Bridge/Fluor Enterprises, a JV**OSM Departure Time:** 1900**Contractor:** Zhenhua Port Machinery Company, Ltd (ZPMC), Changxing Island **Location:** Shanghai, China**CWI Name:** Li Yang**CWI Present:** Yes No**Inspected CWI report:** Yes No N/A**Rod Oven in Use:** Yes No N/A**Electrode to specification:** Yes No N/A**Weld Procedures Followed:** Yes No N/A**Qualified Welders:** Yes No N/A**Verified Joint Fit-up:** Yes No N/A**Approved Drawings:** Yes No N/A**Approved WPS:** Yes No N/A**Delayed / Cancelled:** Yes No N/A**Bridge No:** 34-0006**Component:** OBG Segment**Summary of Items Observed:**

WELDING INSPECTION REPORT

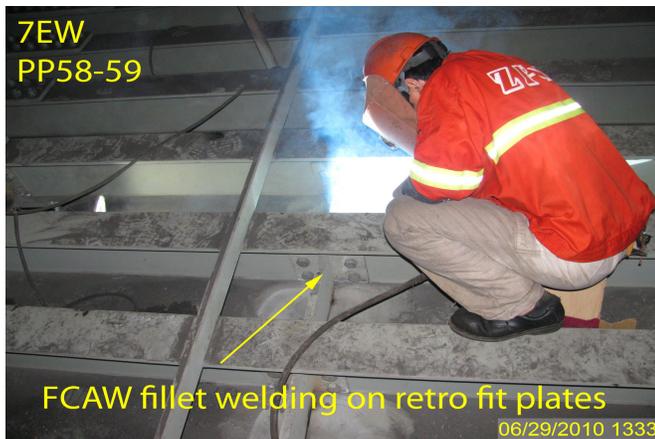
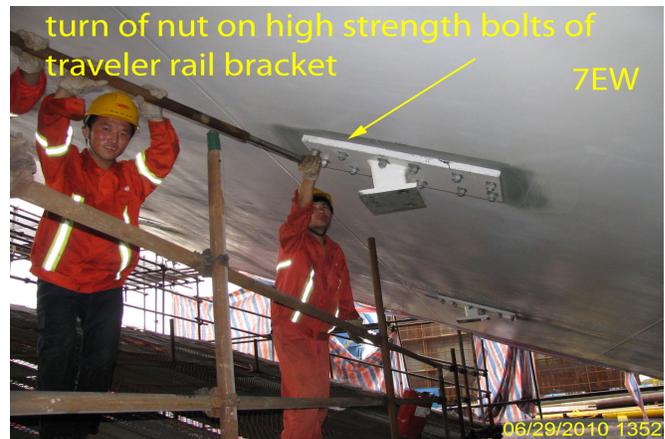
Unless otherwise noted, all work observed on this date appeared to generally comply with applicable contract documents.
