**DEPARTMENT OF TRANSPORTATION**

Contract #: 04-0120F4Cty: SF/ALA Rte: 80 PM: 13.2/13.9File #: 69.28**WELDING INSPECTION REPORT****Resident Engineer:** Pursell, Gary**Address:** 333 Burma Road**City:** Oakland, CA 94607**Report No:** WIR-015324**Date Inspected:** 30-Jun-2010**Project Name:** SAS Superstructure**OSM Arrival Time:** 700**Prime Contractor:** American Bridge/Fluor Enterprises, a JV**OSM Departure Time:** 1900**Contractor:** Zhenhua Port Machinery Company, Ltd (ZPMC), Changxing Island **Location:** Shanghai, China

**Bridge No:** 34-0006**Component:** Tower & OBG Components**Summary of Items Observed:**

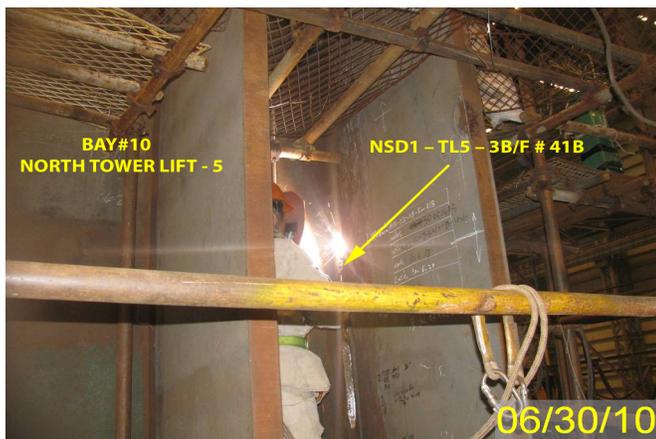
Repair welding of a weld joint # 41B located on North tower Lift-5 NSD1 – TL5 – 3B/F. Welder is identified as 052930. ZPMC Quality Control (QC) Inspector is identified as Gao Zhi Chun. The welding variables recorded by QC appeared to comply with the WPS – 485 – SMAW – 3G (3F) – Repair – 1. (See attached photo)

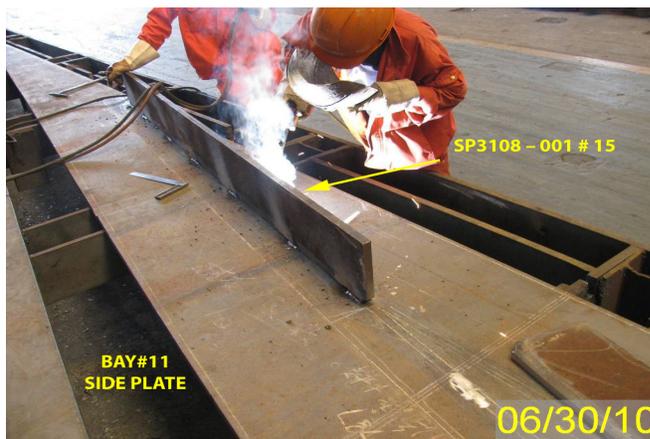
Tack welding of a weld joint # 15 located on Side plate SP3108 – 001. Welder is identified as 057258. ZPMC Quality Control (QC) Inspector is identified as Ma Qian Li. The welding variables recorded by QC appeared to comply with the WPS – B – P – 2112. (See attached photo)
