**DEPARTMENT OF TRANSPORTATION**

Contract #: 04-0120F4Cty: SF/ALA Rte: 80 PM: 13.2/13.9File #: 69.28**WELDING INSPECTION REPORT****Resident Engineer:** Pursell, Gary**Address:** 333 Burma Road**City:** Oakland, CA 94607**Report No:** WIR-015402**Date Inspected:** 25-Jun-2010**Project Name:** SAS Superstructure**OSM Arrival Time:** 700**Prime Contractor:** American Bridge/Fluor Enterprises, a JV**OSM Departure Time:** 1900**Contractor:** Zhenhua Port Machinery Company, Ltd (ZPMC), Changxing Island **Location:** Shanghai, China**CWI Name:** Li Yang**CWI Present:** Yes No**Inspected CWI report:** Yes No N/A**Rod Oven in Use:** Yes No N/A**Electrode to specification:** Yes No N/A**Weld Procedures Followed:** Yes No N/A**Qualified Welders:** Yes No N/A**Verified Joint Fit-up:** Yes No N/A**Approved Drawings:** Yes No N/A**Approved WPS:** Yes No N/A**Delayed / Cancelled:** Yes No N/A**Bridge No:** 34-0006**Component:** OBG Segment**Summary of Items Observed:**

**OBG # TRIAL ASSEMBLY YARD**

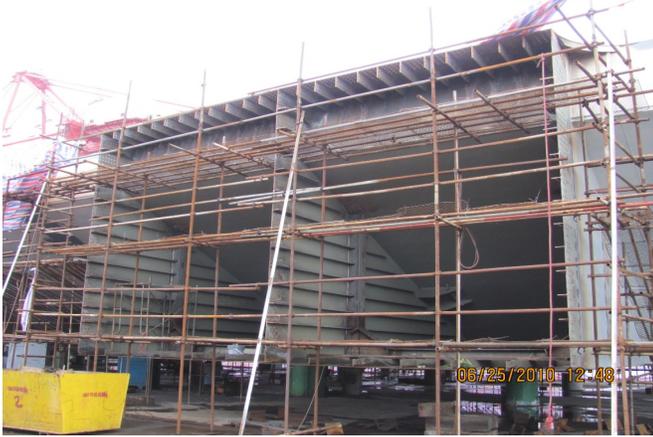
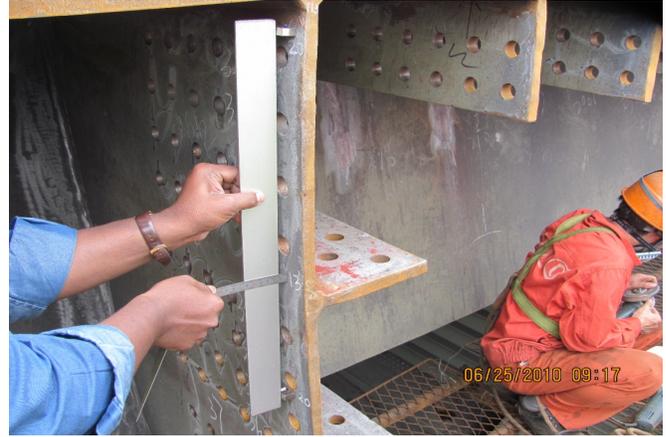
During Quality Assurance (QA) random in-process visual inspection, this QA inspector observed the Floor Beam (FL3) extending to connect with Cross Beam 9 and Cross Beam 10 is out of Flatness for OBG Segment 8AE, 8CE, 8AW and 8CW and does not meet Contract requirements for Skin Plate flatness. Specific details of said non conformance are provided below:

Maximum allowable distortion by AASHTO 11.4.13.2 for this material thickness over a length of 630mm is 5mm. The maximum distortion recorded was at FB24A for Segment 8AE at PP 63 recorded as 6mm over a length of 630mm.

The maximum distortion recorded was at FB28A for Segment 8CE at PP 70 recorded as 6mm over a length of

630mm.

The maximum distortion recorded was at FB23A for Segment 8AW at PP 63 recorded as 6mm over a length of 630mm.

The maximum distortion recorded was at FB27A for Segment 8CW at PP 70 recorded as 7mm over a length of 630mm.

Out of Flatness measured by using 20mm Standard Blocks and 630mm Straight Edge.
