**DEPARTMENT OF TRANSPORTATION**

Contract #: 04-0120F4Cty: SF/ALA Rte: 80 PM: 13.2/13.9File #: 69.28**WELDING INSPECTION REPORT****Resident Engineer:** Pursell, Gary**Address:** 333 Burma Road**City:** Oakland, CA 94607**Report No:** WIR-015412**Date Inspected:** 25-Jun-2010**Project Name:** SAS Superstructure**OSM Arrival Time:** 700**Prime Contractor:** American Bridge/Fluor Enterprises, a JV**OSM Departure Time:** 1900**Contractor:** Zhenhua Port Machinery Company, Ltd (ZPMC), Changxing Island **Location:** Shanghai, China**CWI Name:****CWI Present:**

**Bridge No:** 34-0006**Component:** OBG Trial Assembly**Summary of Items Observed:**

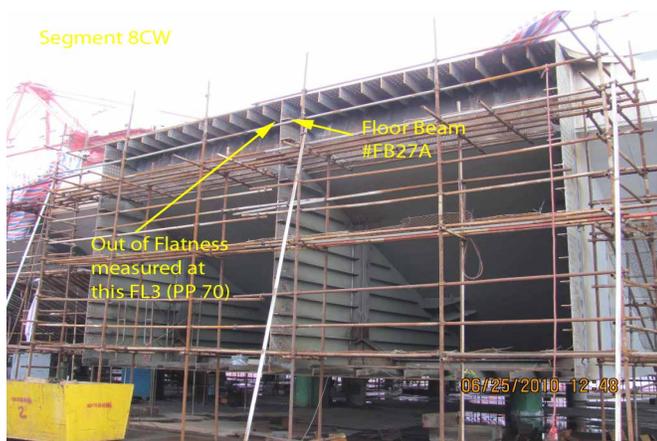
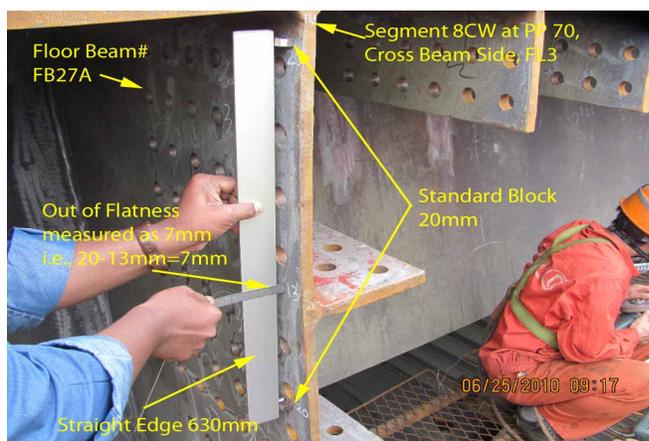
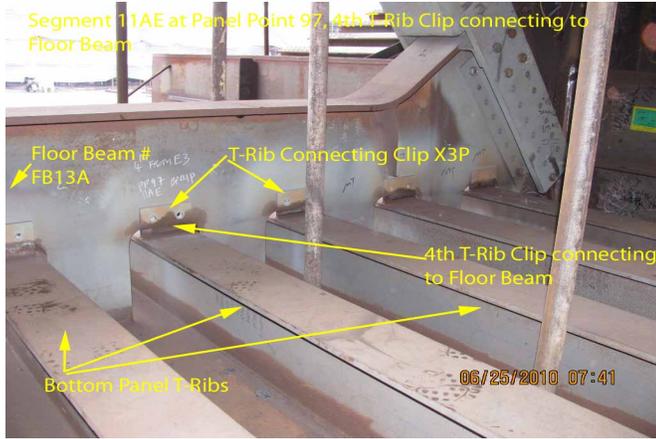
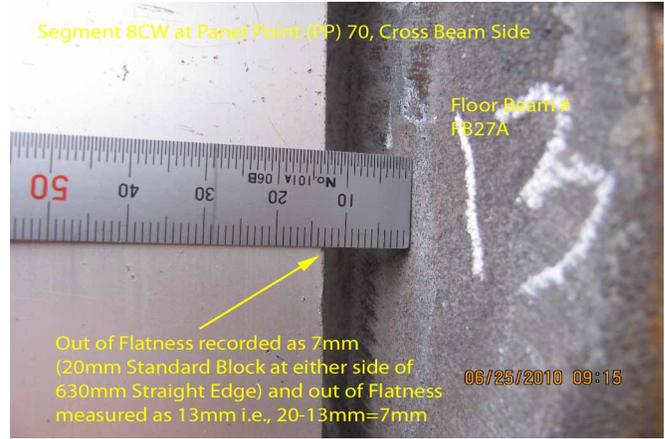
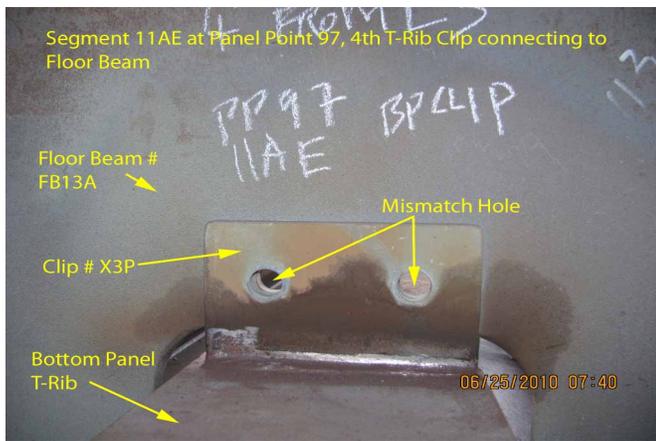
This Quality Assurance (QA) Inspector wrote an Incident Report for mismatch holes at the T-Rib Clips to the Floor Beam from E1 to E3 (Side Panel Bike Path Side) from E3 towards E4 (Bottom Panel) and E4 towards E6 (Side Panel Cross Beam Side) for Segment 11AE at Panel Point (PP) 95, PP 96 and PP 97 more comprehensive details please refer the Incident Report 04-0120F4\_TL-15\_B278\_06-25-09\_Mis-Match Bolt\_Holes\_T-Rib Clips\_FB\_11AE at PP\_95\_96\_97 Dated June 25, 2010. Please refer the attached pictures for more comprehensive details.

This Quality Assurance (QA) Inspector wrote an Incident Report for Out of Flatness for FL3 at Panel 63 for Segment 8AE and 8AW and at Panel Point 70 for 8CE and 8CW for more comprehensive details please refer the Incident Report 04-0120F4\_TL-15\_B278\_06-25-10\_8AE\_8CE\_8AW\_8CW\_Out\_of\_Flatness\_FB\_FL3\_at\_PP\_63
