**DEPARTMENT OF TRANSPORTATION**

Contract #: 04-0120F4Cty: SF/ALA Rte: 80 PM: 13.2/13.9File #: 69.28**WELDING INSPECTION REPORT****Resident Engineer:** Pursell, Gary**Address:** 333 Burma Road**City:** Oakland, CA 94607**Report No:** WIR-015414**Date Inspected:** 28-Jun-2010**Project Name:** SAS Superstructure**OSM Arrival Time:** 700**Prime Contractor:** American Bridge/Fluor Enterprises, a JV**OSM Departure Time:** 1900**Contractor:** Zhenhua Port Machinery Company, Ltd (ZPMC), Changxing Island **Location:** Shanghai, China

## WELDING INSPECTION REPORT

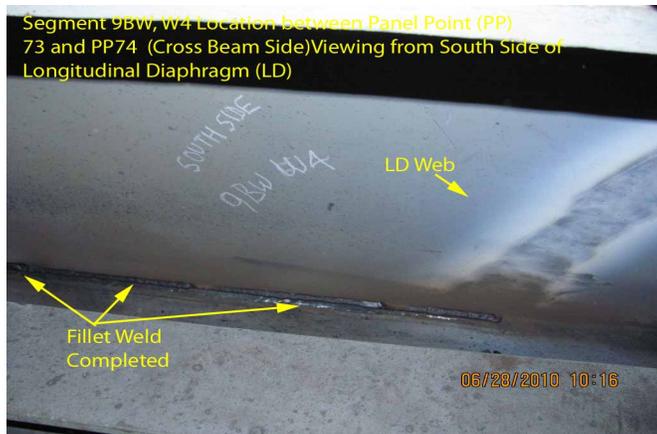
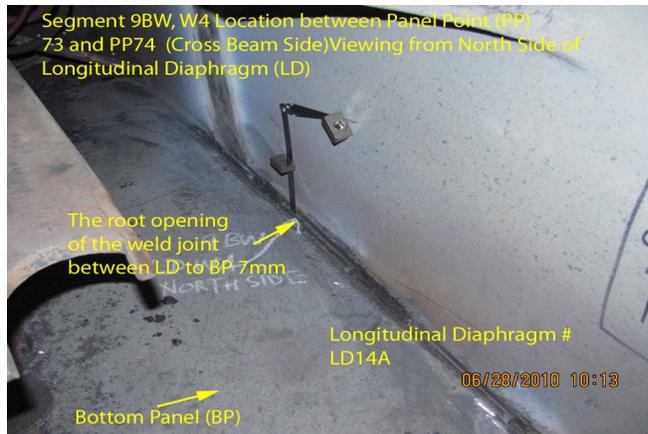
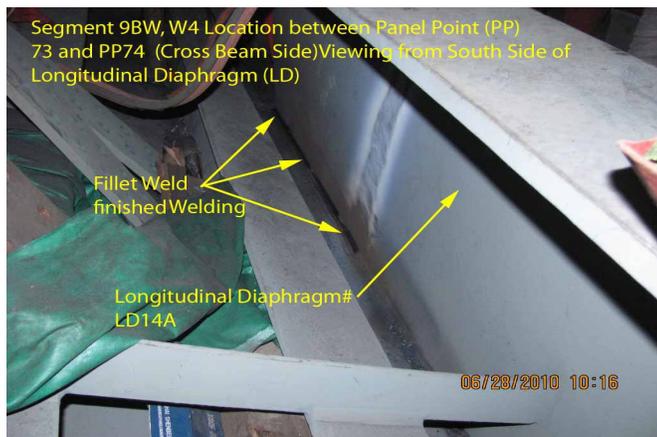
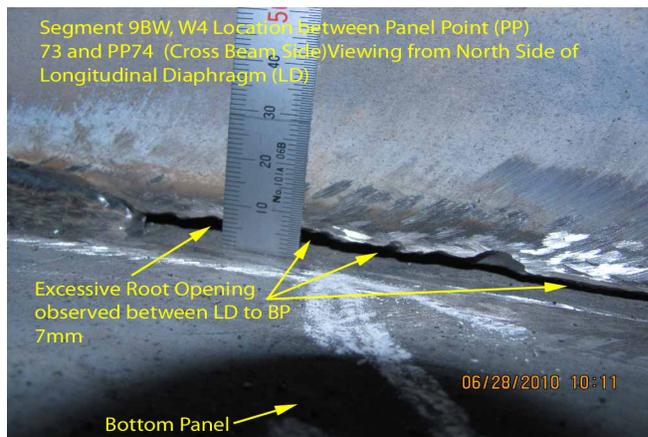
This Quality Assurance (QA) Inspector wrote an Incident Report for Excessive Root Opening at the Bottom Panel (BP) to the Longitudinal Diaphragm (LD) for Segment 9BW between Panel Point (PP) 73 and PP 74 more comprehensive details please refer the Incident Report 04-0120F4\_TL-15\_B278\_06-28-10\_LD\_W4\_Excessive Root Opening\_9BW Dated June 28, 2010. Please refer the attached pictures for more comprehensive details.
