**DEPARTMENT OF TRANSPORTATION**

Contract #: 04-0120F4Cty: SF/ALA Rte: 80 PM: 13.2/13.9File #: 69.28**WELDING INSPECTION REPORT****Resident Engineer:** Pursell, Gary**Address:** 333 Burma Road**City:** Oakland, CA 94607**Report No:** WIR-016035**Date Inspected:** 10-Jun-2010**Project Name:** SAS Superstructure**OSM Arrival Time:** 700**Prime Contractor:** American Bridge/Fluor Enterprises, a JV**OSM Departure Time:** 1900**Contractor:** Zhenhua Port Machinery Company, Ltd (ZPMC), Changxing Island **Location:** Shanghai, China**CWI Name:** Mr. Li Jia**CWI Present:** Yes No**Inspected CWI report:** Yes No N/A**Rod Oven in Use:** Yes No N/A**Electrode to specification:** Yes No N/A**Weld Procedures Followed:** Yes No N/A**Qualified Welders:** Yes No N/A**Verified Joint Fit-up:** Yes No N/A**Approved Drawings:** Yes No N/A**Approved WPS:** Yes No N/A**Delayed / Cancelled:** Yes No N/A**Bridge No:** 34-0006**Component:** Orthotropic Box Girder (OBG)**Summary of Items Observed:**

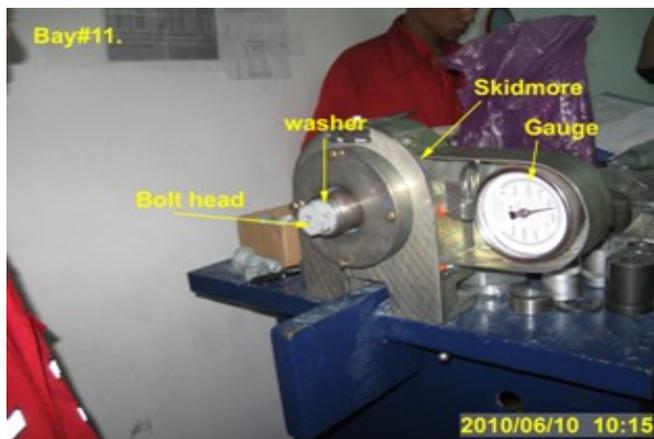
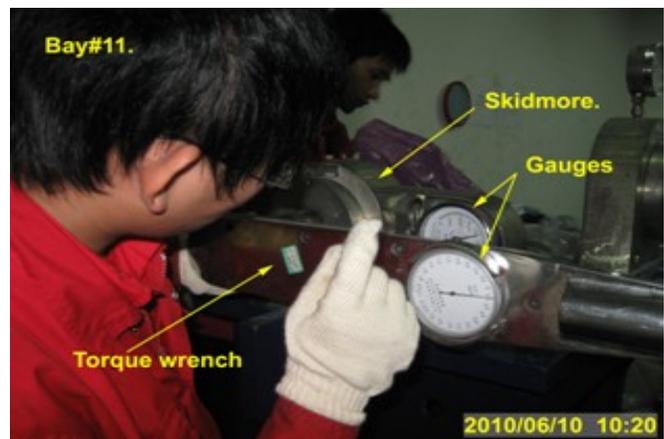
This QA inspector witnessed the lot testing of the A325M High Strength Bolts to determine the torque values for the minimum tension required. The tension testing is performed by turning the bolt head. Below is a list of the lots tested and the average torque values determined.

1. Bolt Lot No: MF131Z, size M22 x 55, RC Set# DHGM220011, Nut Lot No: KZ792Z, Washer Lot No: B9947Z and average torque value was 966 N-m.

2. Bolt Lot No: NC721Z, size M22 x 110, RC Set# DHGM220067, Nut Lot No: ND131Z, Washer Lot No: C0428Y and average torque value was 973 N-m.

Refer attached photos for reference.
