Contract #: 04-0120F4Cty: SF/ALA Rte: 80 PM: 13.2/13.9File #: 69.28**WELDING INSPECTION REPORT****Resident Engineer:** Pursell, Gary**Address:** 333 Burma Road**City:** Oakland, CA 94607**Report No:** WIR-015500**Date Inspected:** 08-Jul-2010**Project Name:** SAS Superstructure**OSM Arrival Time:** 700**Prime Contractor:** American Bridge/Fluor Enterprises, a JV**OSM Departure Time:** 1900**Contractor:** Zhenhua Port Machinery Company, Ltd (ZPMC), Changxing Island **Location:** Shanghai, China

Orthotropic Box Girder (OBG) Trial Assembly Areas

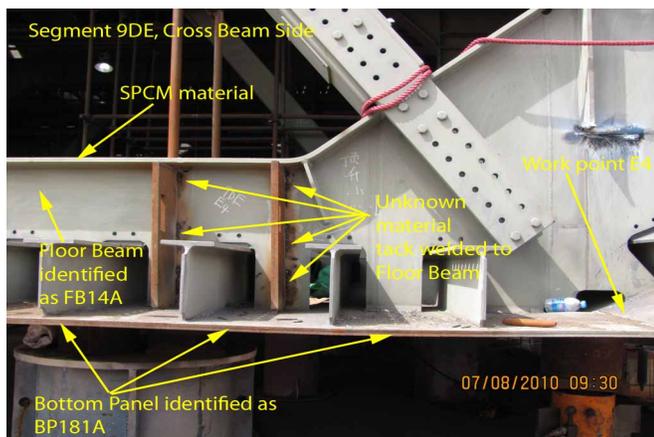
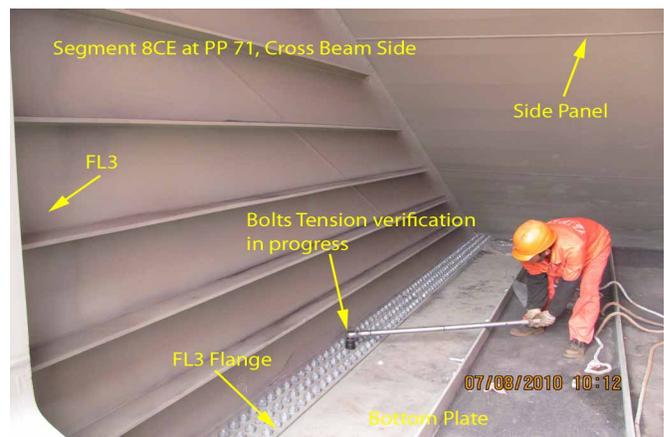
This QA Inspector witnessed the final bolt tension verification on bolts connecting the FL3 Flange to the Bottom Plate and the Bottom Plate to Bottom Panel between Panel Points (PP) 69, PP 70 and PP 71 for Segment 8CE. The QA Inspector verified the bolt tension on a random basis and the results appeared to be in general compliance. The Inspection was performed against Notification No. 00413 dated July 08, 2010.

The manual torque wrench used to verify tension was S/N XO-747 and S/N XO2-666. Please reference the pictures attached for more comprehensive details.

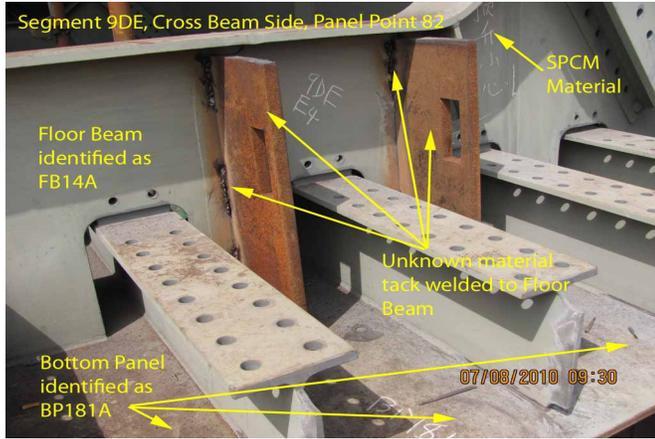
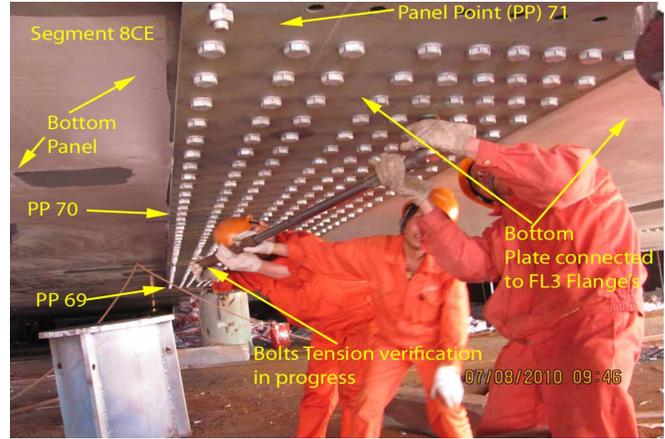
This Quality Assurance (QA) Inspector wrote an Incident Report for welding the unknown material to the Floor Beam FB14A at E4 Location for Segment 9DE at Panel Point (PP) 82. Please refer the Incident Report # 04-0120F4_TL-15_B278_07-08-2010_Floor Beam_9DE_Unknown Material dated July 08, 2010.

Please reference the pictures attached for more comprehensive details.
