DEPARTMENT OF TRANSPORTATION

Contract #: 04-0120F4Cty: SF/ALA Rte: 80 PM: 13.2/13.9File #: 69.28**WELDING INSPECTION REPORT****Resident Engineer:** Pursell, Gary**Address:** 333 Burma Road**City:** Oakland, CA 94607**Report No:** WIR-015536**Date Inspected:** 06-Jul-2010**Project Name:** SAS Superstructure**OSM Arrival Time:** 700**Prime Contractor:** American Bridge/Fluor Enterprises, a JV**OSM Departure Time:** 1900**Contractor:** Zhenhua Port Machinery Company, Ltd (ZPMC), Changxing Island **Location:** Shanghai, China

CWI Name:	Mr. Xu Le Feng/ Mr. Qiu Wen	CWI Present:	Yes	No
Inspected CWI report:	Yes No N/A	Rod Oven in Use:	Yes	No N/A
Electrode to specification:	Yes No N/A	Weld Procedures Followed:	Yes	No N/A
Qualified Welders:	Yes No N/A	Verified Joint Fit-up:	Yes	No N/A
Approved Drawings:	Yes No N/A	Approved WPS:	Yes	No N/A
		Delayed / Cancelled:	Yes	No N/A
Bridge No:	34-0006	Component:	Tower

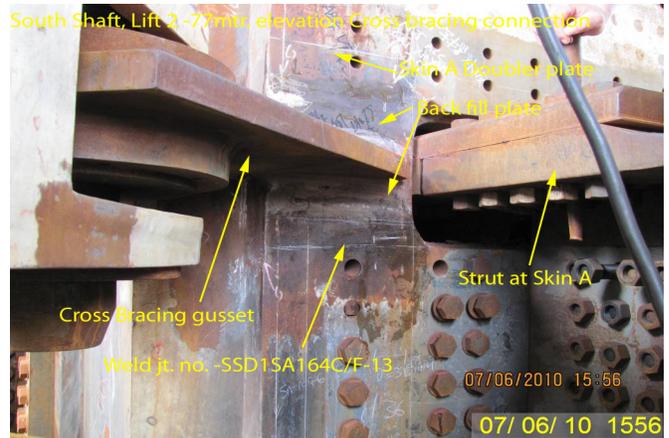
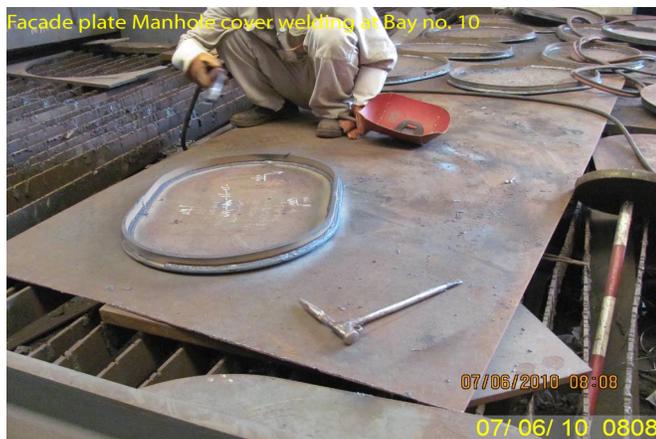
5.This QA inspector, Baskar Govindarajan, observed during random 10% verification of Ultrasonic Testing (UT) of Doubler Plate to Backfill Plate, One Class "B" non conforming longitudinal indication measuring approximately 60 mm in length found in 77 mtr. elevation of South shaft, Lift2. Depth of the discontinuity from face A is approximately 37 mm, and Y location found to be 15 mm from Strut side. Reported the same to Task leader, and Incident report written. (Photo attached)
