Quality Assurance and Source Inspection

Contract #: 04-0120F4Cty: SF/ALA Rte: 80 PM: 13.2/13.9File #: 69.28**WELDING INSPECTION REPORT****Resident Engineer:** Pursell, Gary**Address:** 333 Burma Road**City:** Oakland, CA 94607**Report No:** WIR-015603**Date Inspected:** 06-Jul-2010**Project Name:** SAS Superstructure**OSM Arrival Time:** 1900**Prime Contractor:** American Bridge/Fluor Enterprises, a JV**OSM Departure Time:** 700**Contractor:** Zhenhua Port Machinery Company, Ltd (ZPMC), Changxing Island **Location:** Shanghai, China**CWI Name:** See Below**CWI Present:** Yes No**Inspected CWI report:** Yes No N/A**Rod Oven in Use:** Yes No N/A**Electrode to specification:** Yes No N/A**Weld Procedures Followed:** Yes No N/A**Qualified Welders:** Yes No N/A**Verified Joint Fit-up:** Yes No N/A**Approved Drawings:** Yes No N/A**Approved WPS:** Yes No N/A**Delayed / Cancelled:** Yes No N/A**Bridge No:** 34-0006**Component:** OBG**Summary of Items Observed:**

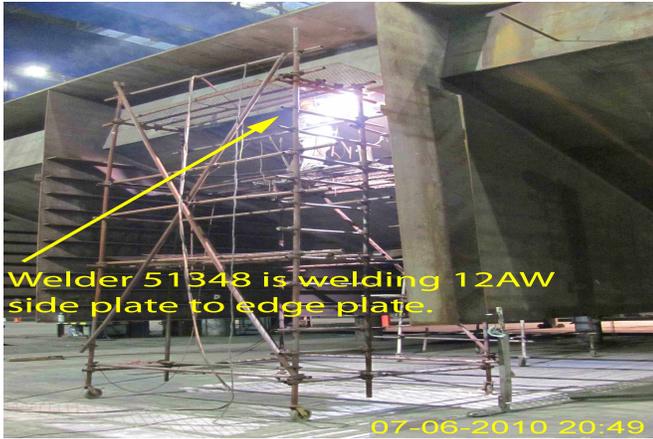
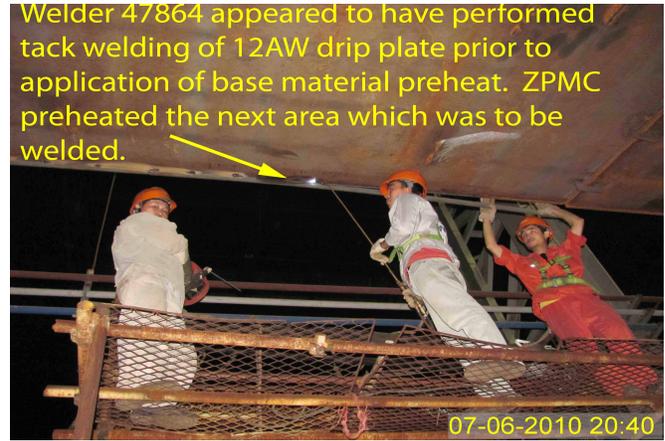
This QA Inspector observed ZPMC welder Mr. Wang Chang Ming, stencil 047864 was using shielded metal arc welding process to complete OBG segment 12AW drip plate tack welds on the counterweight side near panel point PP110. This QA Inspector asked ZPMC QC Inspector Mr. Li Ping what is the weld number for these drip plate welds and which welding procedure is being used to make these tack welds. Mr. Li Ping informed this QA Inspector that he does not know the weld numbers and he does not know the welding procedure specification that is being used. This QA Inspector observed Mr. Wang Chang Ming is welding in the 4F position and he has a welding current of approximately 155 amps. This QA Inspector observed the base material adjacent to the tack weld appears to be at an ambient temperature instead of being preheated prior to welding. This QA Inspector informed ZPMC QC Inspector Mr. Li Ping that the base material where the last tack weld was made did not appear to have been preheated and Mr. Li Ping informed Mr. Wang Chang Ming to preheat the base material prior to making any additional tack welds. Approximately ten minutes later this QA Inspector again observed the base material where Mr. Wang Chang Ming was making another tack weld appears to be at an ambient temperature.

This QA Inspector asked QC Inspector Mr. Li Ping to request ZPMC CWI Mr. Wu Shi Gao to come to OBG segment 12AW. When Mr. Wu Shi Gao arrived in OBG bay 14 this QA Inspector informed him that ZPMC welder Mr. Wang Chang Ming did not appear to have been preheating the base material prior to making tack welds on OBG segment drip plate tack welds. Mr. Wu Shi Gao informed this QA Inspector that he will have the tack welds removed and new tack welds will be installed. This QA Inspector informed Mr. Wu Shi Gao that QC Inspector Mr. Li Ping did not know the weld numbers or the WPS for these tack welds. Mr. Wu Shi Gao informed this QA Inspector that he will inform this QA Inspector once he determines the weld numbers and the WPS. Items observed on this date do not appear to fully comply with applicable contract documents. See the photograph below for additional information. CWI Mr. Wu Shi Gao later informed this QA Inspector that the drip plate weld numbers are OBW11B-002 and OBW11B-003.
