DEPARTMENT OF TRANSPORTATION

Contract #: 04-0120F4Cty: SF/ALA Rte: 80 PM: 13.2/13.9File #: 69.28**WELDING INSPECTION REPORT****Resident Engineer:** Pursell, Gary**Address:** 333 Burma Road**City:** Oakland, CA 94607**Report No:** WIR-015652**Date Inspected:** 15-Jul-2010**Project Name:** SAS Superstructure**OSM Arrival Time:** 700**Prime Contractor:** American Bridge/Fluor Enterprises, a JV**OSM Departure Time:** 1700**Contractor:** Zhenhua Port Machinery Company, Ltd (ZPMC), Changxing Island **Location:** Shanghai, China**CWI Name:** Li Yang**CWI Present:** Yes No**Inspected CWI report:** Yes No N/A**Rod Oven in Use:** Yes No N/A**Electrode to specification:** Yes No N/A**Weld Procedures Followed:** Yes No N/A**Qualified Welders:** Yes No N/A**Verified Joint Fit-up:** Yes No N/A**Approved Drawings:** Yes No N/A**Approved WPS:** Yes No N/A**Delayed / Cancelled:** Yes No N/A**Bridge No:** 34-0006**Component:** OBG Segment**Summary of Items Observed:**

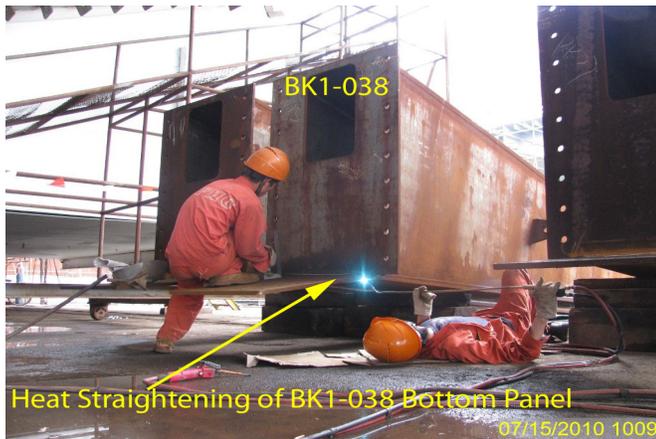
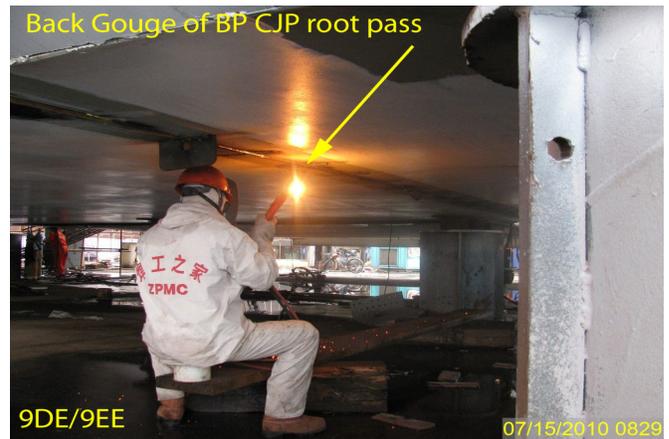
This QA Inspector observed heat straightening of the Bottom Panel of the bike path cantilever at weld BK001-038-006 following HSR1(B)-8834.
