DEPARTMENT OF TRANSPORTATION

Contract #: 04-0120F4Cty: SF/ALA Rte: 80 PM: 13.2/13.9File #: 69.28**WELDING INSPECTION REPORT****Resident Engineer:** Pursell, Gary**Address:** 333 Burma Road**City:** Oakland, CA 94607**Report No:** WIR-015921**Date Inspected:** 27-Jul-2010**Project Name:** SAS Superstructure**OSM Arrival Time:** 700**Prime Contractor:** American Bridge/Fluor Enterprises, a JV**OSM Departure Time:** 1900**Contractor:** Zhenhua Port Machinery Company, Ltd (ZPMC), Changxing Island **Location:** Shanghai, China

Orthotropic Box Girder (OBG) Trial Assembly Areas

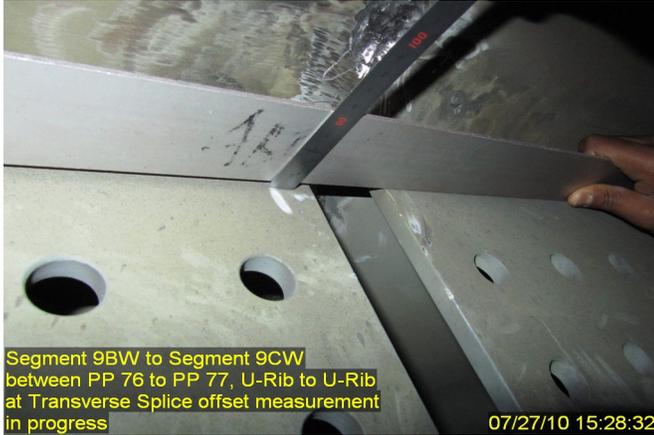
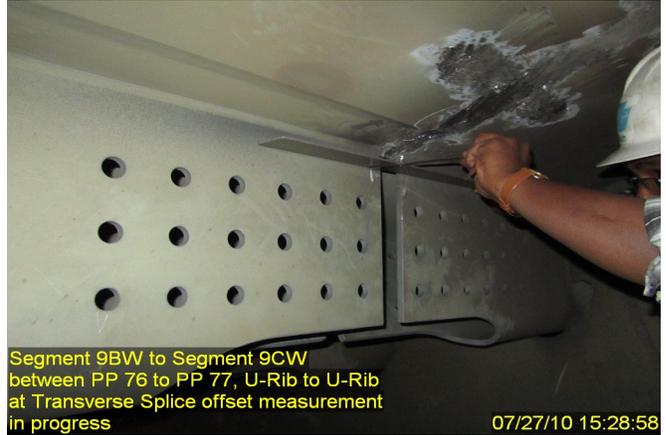
Lead Inspector and Engineer for review and disposition. Please reference the pictures attached for more comprehensive details.

Unless otherwise noted, all work observed on this date appeared to generally comply with applicable contract documents.
