DEPARTMENT OF TRANSPORTATION

Quality Assurance and Source Inspection

Contract #: 04-0120F4Cty: SF/ALA Rte: 80 PM: 13.2/13.9File #: 69.28**WELDING INSPECTION REPORT****Resident Engineer:** Pursell, Gary**Address:** 333 Burma Road**City:** Oakland, CA 94607**Report No:** WIR-015926**Date Inspected:** 28-Jul-2010**Project Name:** SAS Superstructure**OSM Arrival Time:** 700**Prime Contractor:** American Bridge/Fluor Enterprises, a JV**OSM Departure Time:** 1900**Contractor:** Zhenhua Port Machinery Company, Ltd (ZPMC), Changxing Island **Location:** Shanghai, China**CWI Name:** Li Yang and Zhu Zhong Hai**CWI Present:** Yes No**Inspected CWI report:** Yes No N/A**Rod Oven in Use:** Yes No N/A**Electrode to specification:** Yes No N/A**Weld Procedures Followed:** Yes No N/A**Qualified Welders:** Yes No N/A**Verified Joint Fit-up:** Yes No N/A**Approved Drawings:** Yes No N/A**Approved WPS:** Yes No N/A**Delayed / Cancelled:** Yes No N/A**Bridge No:** 34-0006**Component:** OBG Trial Assembly**Summary of Items Observed:**

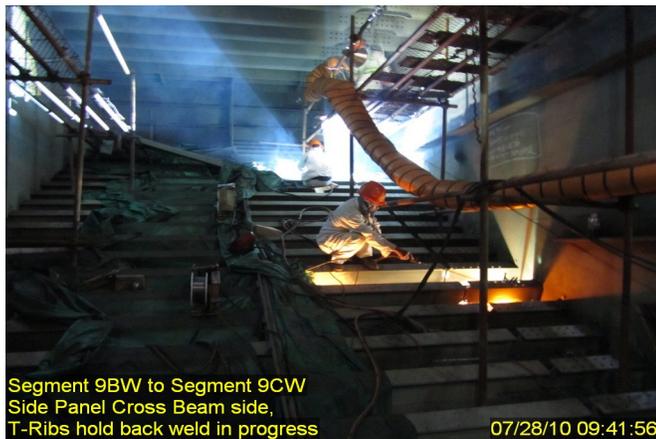
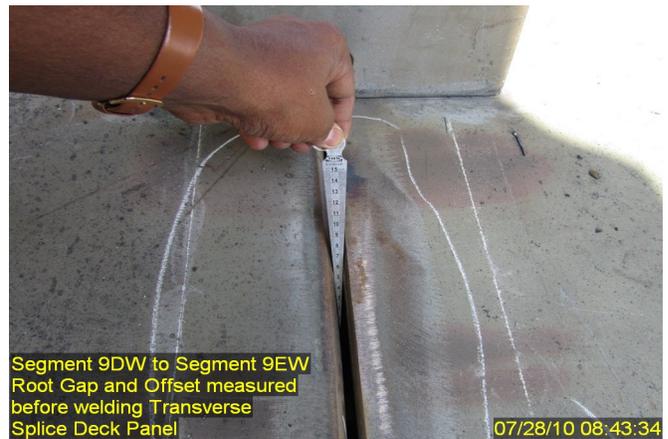
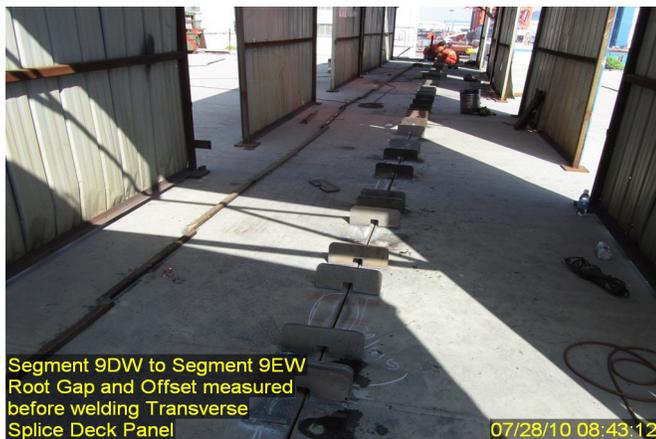
This QA Inspector performed Dimension Control Inspection for measuring Root Gap and Offset at the Transverse Splice for the Segment 9DW to Segment 9EW between Panel Point (PP) 82 to PP 83 at the following locations:

Please reference the pictures attached for more comprehensive details.

This QA Inspector observed the in process fillet welding operation by the Flux Cored Arc Welding (FCAW) process. The weld joint was designated as SP770-001-035 and SP771-001-011. The welder identification was 045143 and was observed welding in the 2F (Horizontal) position using approved Welding Procedure Specification WPS-B-T-2132. The piece mark was identified as the Side Panel T-Ribs, Cross Beam side. Please reference the pictures attached for more comprehensive details.

This QA Inspector observed the in process fillet welding operation by the Flux Cored Arc Welding (FCAW) process. The weld joint was designated as SP492-001-059 and SP493-001-003. The welder identification was 045280 and was observed welding in the 2F (Horizontal) position using approved Welding Procedure Specification WPS-B-T-2132. The piece mark was identified as the Side Panel T-Ribs, Cross Beam side. Please reference the pictures attached for more comprehensive details.
