DEPARTMENT OF TRANSPORTATION

Contract #: 04-0120F4Cty: SF/ALA Rte: 80 PM: 13.2/13.9File #: 69.28**WELDING INSPECTION REPORT****Resident Engineer:** Pursell, Gary**Address:** 333 Burma Road**City:** Oakland, CA 94607**Report No:** WIR-015939**Date Inspected:** 31-Jul-2010**Project Name:** SAS Superstructure**OSM Arrival Time:** 700**Prime Contractor:** American Bridge/Fluor Enterprises, a JV**OSM Departure Time:** 1900**Contractor:** Zhenhua Port Machinery Company, Ltd (ZPMC), Changxing Island **Location:** Shanghai, China**CWI Name:** Li Yang and Zhu Zhong Hai**CWI Present:** Yes No**Inspected CWI report:** Yes No N/A**Rod Oven in Use:** Yes No N/A**Electrode to specification:** Yes No N/A**Weld Procedures Followed:** Yes No N/A**Qualified Welders:** Yes No N/A**Verified Joint Fit-up:** Yes No N/A**Approved Drawings:** Yes No N/A**Approved WPS:** Yes No N/A**Delayed / Cancelled:** Yes No N/A**Bridge No:** 34-0006**Component:** OBG Trial Assembly**Summary of Items Observed:**

Orthotropic Box Girder (OBG) Trial Assembly Areas

WELDING INSPECTION REPORT

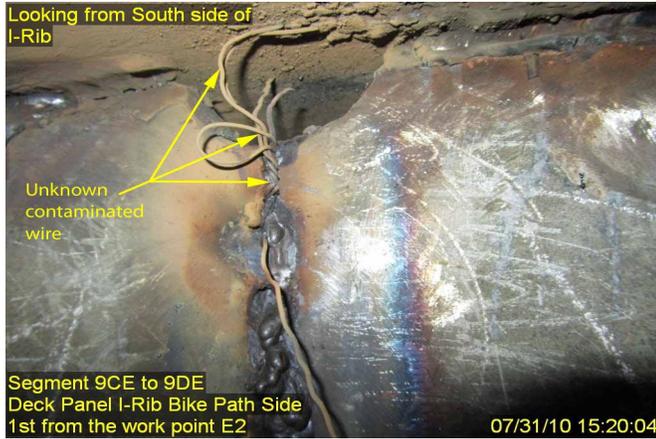
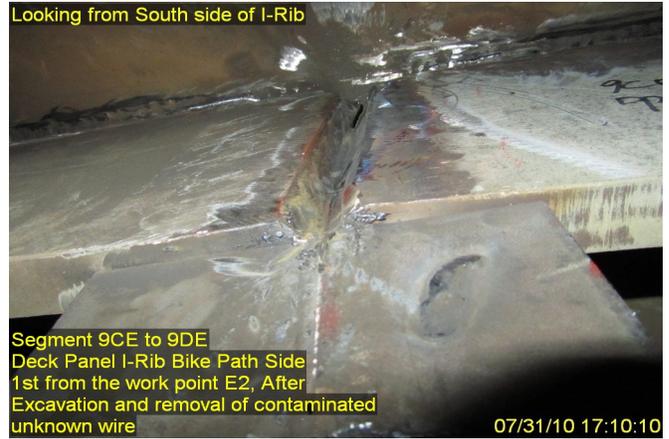
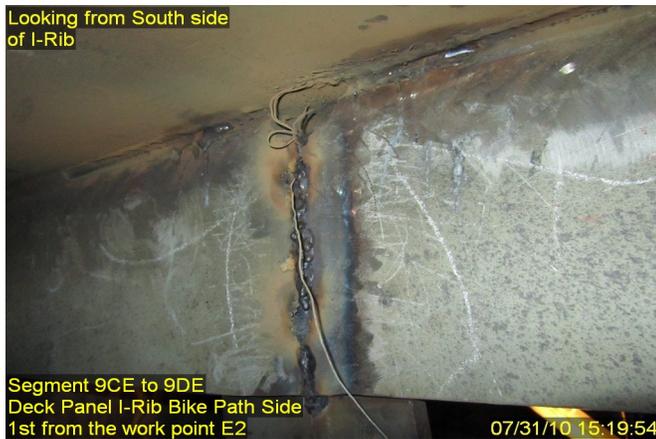
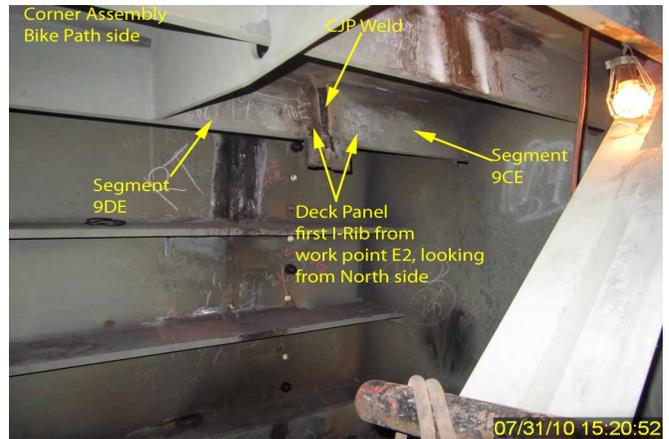
This QA Inspector observed during the random visual inspection that welding by Shielded Metal Arc Welding (SMAW) process on a Complete Joint Penetration (CJP) groove weld was in-process and other side of the joint at the root run unknown steel wire was found to be the part of the weld. The issue was brought up to ZPMC QC Mr. Wang Li Yang and ABF QA Mr. Ding Xing Chi. As per the concurrence from Caltrans Lead Inspector it was concluded to remove the weld of interest which was contaminated by unknown steel wire. Please reference the pictures attached for more comprehensive details.

The Weld joint was designated as DP712-001-021. The welder identification was 053753 and was observed welding in the 4G (Overhead) position using approved Welding Procedure Specification WPS-345-SMAW-4G (4F)-FCM-Repair-1. The piece mark was identified as the Deck Panel I-Rib first from the work point E2 at bike path side. Please reference the pictures attached for more comprehensive details.
