DEPARTMENT OF TRANSPORTATION

Contract #: 04-0120F4Cty: SF/ALA Rte: 80 PM: 13.2/13.9File #: 69.28**WELDING INSPECTION REPORT****Resident Engineer:** Pursell, Gary**Address:** 333 Burma Road**City:** Oakland, CA 94607**Report No:** WIR-015980**Date Inspected:** 22-Jul-2010**Project Name:** SAS Superstructure**OSM Arrival Time:** 700**Prime Contractor:** American Bridge/Fluor Enterprises, a JV**OSM Departure Time:** 1900**Contractor:** Zhenhua Port Machinery Company, Ltd (ZPMC), Changxing Island **Location:** Shanghai, China

Ultrasonic Testing (UT)

Visual Inspection after Blast at 10BE

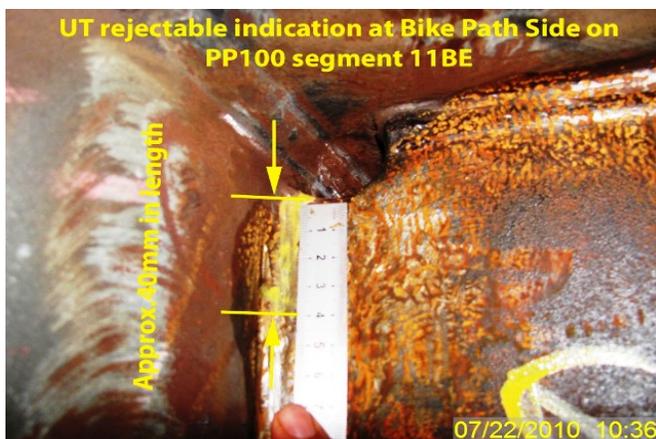
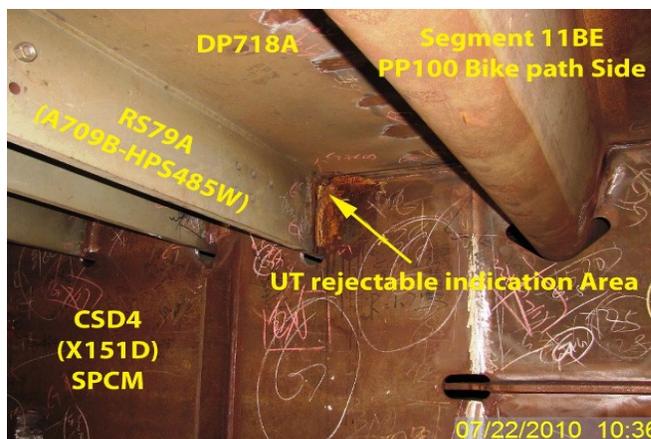
During the Quality Assurance Ultrasonic Testing (UT) review of welds located on Orthotropic Box Girder (OBG) segment 11BE, this Quality Assurance Inspector (QA) discovered the following issues that One (1) longitudinal linear indication measuring approximately 40mm in length. The indication dbS rating is a +6. Material thickness is 22mm. The depth of the indication is approximately 12mm. The weld is identified as CSD4-PP100-130 at Bike Path Side, Panel Point PP100. The weld is fillet weld according to approved shop drawing but due to excessive root gap ZPMC changed to Complete Joint Penetration (CJP) "T" joint. The joint joining between Corner Assembly Diaphragm (X151D) to Deck Plate Stiffener (RS79A). The weld is designated as Seismic Performance Critical Material (SPCM). The indication is clearly marked on or near the weld. The Y distance for this indication is 5 mm from top Cope hole. Segment 11BE is located at near trial assembly Yard. The Notice of Witness Inspection (NWIT) No. is 006235. The indication is located Within an area previously tested and accepted by ZPMC Quality Control (QC) personnel. As per the contract documents, ZPMC's QC personnel are required to perform hundred (100%) percent UT inspection of this weld.
