Contract #: 04-0120F4Cty: SF/ALA Rte: 80 PM: 13.2/13.9File #: 69.28**WELDING INSPECTION REPORT****Resident Engineer:** Pursell, Gary**Address:** 333 Burma Road**City:** Oakland, CA 94607**Report No:** WIR-016148**Date Inspected:** 10-Aug-2010**Project Name:** SAS Superstructure**OSM Arrival Time:** 700**Prime Contractor:** American Bridge/Fluor Enterprises, a JV**OSM Departure Time:** 1900**Contractor:** Zhenhua Port Machinery Company, Ltd (ZPMC), Changxing Island **Location:** Shanghai, China

CWI Name:	N/a	CWI Present:	Yes	No
Inspected CWI report:	Yes No N/A	Rod Oven in Use:	Yes	No N/A
Electrode to specification:	Yes No N/A	Weld Procedures Followed:	Yes	No N/A
Qualified Welders:	Yes No N/A	Verified Joint Fit-up:	Yes	No N/A
Approved Drawings:	Yes No N/A	Approved WPS:	Yes	No N/A
		Delayed / Cancelled:	Yes	No N/A
Bridge No:	34-0006	Component:	OBG Trial Assembly

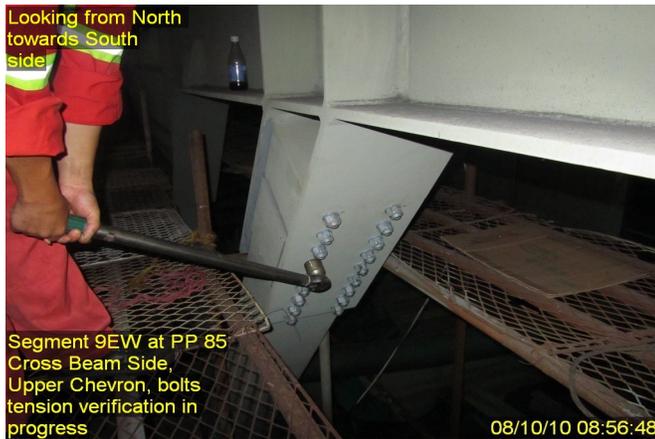
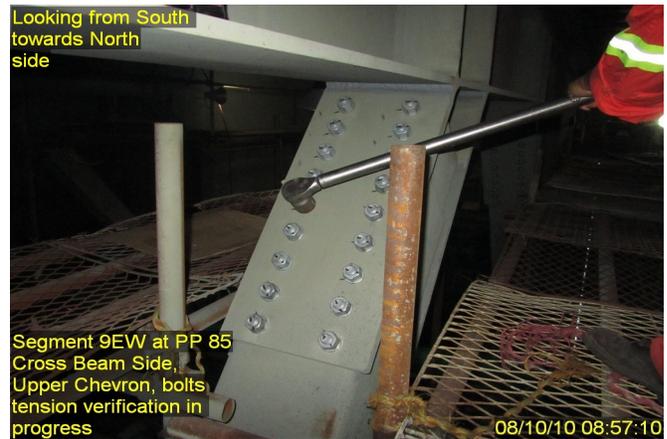
This QA Inspector witnessed the final bolt tension verification on bolts connecting the T-Ribs Clips to Floor Beam at Side Panel (Cross Beam and Counter Weight side) and Bottom Panel at the Panel Points (PP) 83, PP 84 and PP 85 for Segment 9EW. The QA Inspector verified the bolt tension on a random basis and the results appeared to be in general compliance. The Inspection was performed against Notification No. 00449 dated August 10, 2010.
