DEPARTMENT OF TRANSPORTATION

Contract #: 04-0120F4Cty: SF/ALA Rte: 80 PM: 13.2/13.9File #: 69.28**WELDING INSPECTION REPORT****Resident Engineer:** Pursell, Gary**Address:** 333 Burma Road**City:** Oakland, CA 94607**Report No:** WIR-016150**Date Inspected:** 11-Aug-2010**Project Name:** SAS Superstructure**OSM Arrival Time:** 700**Prime Contractor:** American Bridge/Fluor Enterprises, a JV**OSM Departure Time:** 1900**Contractor:** Zhenhua Port Machinery Company, Ltd (ZPMC), Changxing Island **Location:** Shanghai, China**CWI Name:** Li Yang and Zhu Zhong Hai**CWI Present:** Yes No**Inspected CWI report:** Yes No N/A**Rod Oven in Use:** Yes No N/A**Electrode to specification:** Yes No N/A**Weld Procedures Followed:** Yes No N/A**Qualified Welders:** Yes No N/A**Verified Joint Fit-up:** Yes No N/A**Approved Drawings:** Yes No N/A**Approved WPS:** Yes No N/A**Delayed / Cancelled:** Yes No N/A**Bridge No:** 34-0006**Component:** OBG Trial Assembly**Summary of Items Observed:**

Orthotropic Box Girder (OBG) Trial Assembly Areas

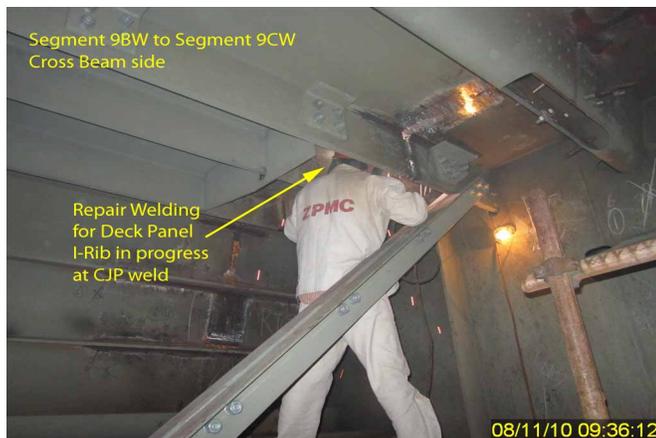
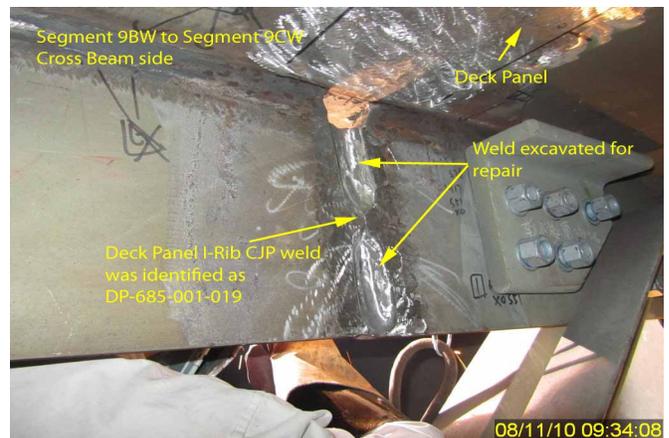
This QA Inspector observed the repair welding by Shielded Metal Arc Welding (SMAW) process on a Complete Joint Penetration (CJP) groove weld. The Weld joint was designated as DP685-001-019. The welder identification was 045196 and was observed welding in the 3G (Vertical) position using approved Welding Procedure Specification WPS-485-SMAW-3G(3F)-FCM-Repair-1. The piece mark was identified as the Deck Panel I-Ribs, Cross Beam side. ZPMC performed repair welding in accordance with CWR-14515. Please reference the pictures attached for more comprehensive details.
