Contract #: 04-0120F4Cty: SF/ALA Rte: 80 PM: 13.2/13.9File #: 69.28**WELDING INSPECTION REPORT****Resident Engineer:** Pursell, Gary**Address:** 333 Burma Road**City:** Oakland, CA 94607**Report No:** WIR-016187**Date Inspected:** 05-Aug-2010**Project Name:** SAS Superstructure**OSM Arrival Time:** 700**Prime Contractor:** American Bridge/Fluor Enterprises, a JV**OSM Departure Time:** 1900**Contractor:** Zhenhua Port Machinery Company, Ltd (ZPMC), Changxing Island **Location:** Shanghai, China**CWI Name:** Mr. Wu shi guo/Xu Tao**CWI Present:** Yes No**Inspected CWI report:** Yes No N/A**Rod Oven in Use:** Yes No N/A**Electrode to specification:** Yes No N/A**Weld Procedures Followed:** Yes No N/A**Qualified Welders:** Yes No N/A**Verified Joint Fit-up:** Yes No N/A**Approved Drawings:** Yes No N/A**Approved WPS:** Yes No N/A**Delayed / Cancelled:** Yes No N/A**Bridge No:** 34-0006**Component:** OBG**Summary of Items Observed:**

In process Inspection

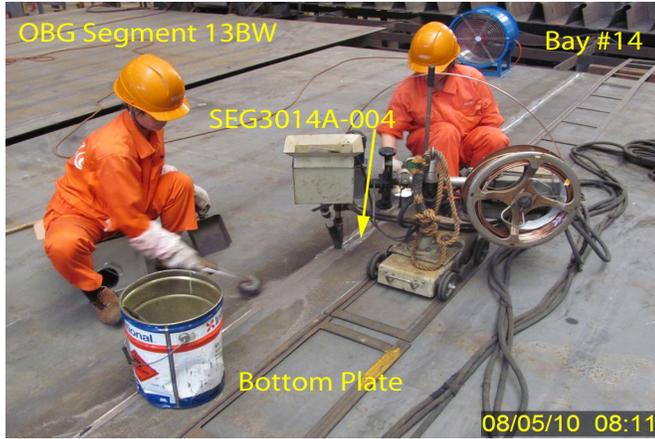
SAW in the 1G position for the OBG Segment 13BW Bottom Plate weld No: SEG3014A-004. The welder is identified as #045270. ZPMC QC is identified as Mr. Wang xu. The welding variables recorded by QC appear to comply with WPS-B-T-2221-B-L2C-S-2. Please see the attached picture.

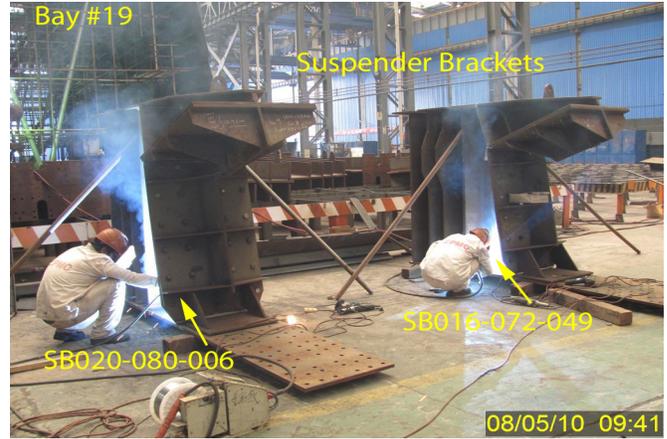
FCAW in the 2G position for the Suspender Bracket weld No: SB016-072-049. The welder is identified as #062761. ZPMC CWI is identified as Mr. Xu Tao. The welding variables recorded by QC appear to comply with WPS-B-T-2232-TC-U4b-F. Please see the attached picture.
