DEPARTMENT OF TRANSPORTATION

Contract #: 04-0120F4Cty: SF/ALA Rte: 80 PM: 13.2/13.9File #: 99.28**WELDING INSPECTION REPORT****Resident Engineer:** Pursell, Gary**Address:** 333 Burma Road**City:** Oakland, CA 94607**Report No:** WIR-016195**Date Inspected:** 03-Aug-2010**Project Name:** SAS Superstructure**OSM Arrival Time:** 700**Prime Contractor:** American Bridge/Fluor Enterprises, a JV**OSM Departure Time:** 1900**Contractor:** Zhenhua Port Machinery Company, Ltd (ZPMC) Chanxing Island **Location:** Shanghai, China**CWI Name:** Mr. Geng Wei**CWI Present:** Yes No**Inspected CWI report:** Yes No N/A**Rod Oven in Use:** Yes No N/A**Electrode to specification:** Yes No N/A**Weld Procedures Followed:** Yes No N/A**Qualified Welders:** Yes No N/A**Verified Joint Fit-up:** Yes No N/A**Approved Drawings:** Yes No N/A**Approved WPS:** Yes No N/A**Delayed / Cancelled:** Yes No N/A**Bridge No:** 34-0006**Component:** OBG Segments**Summary of Items Observed:**

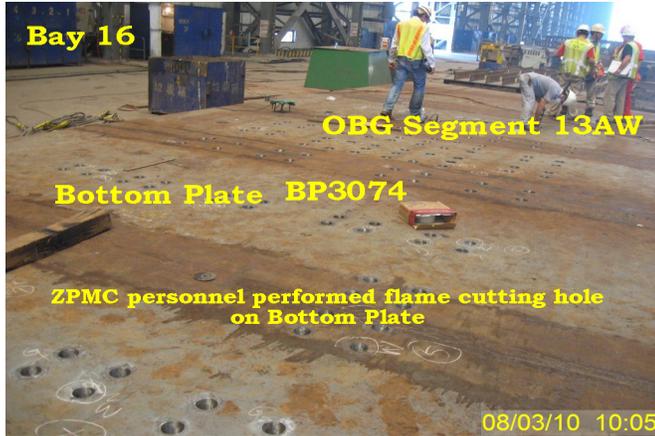
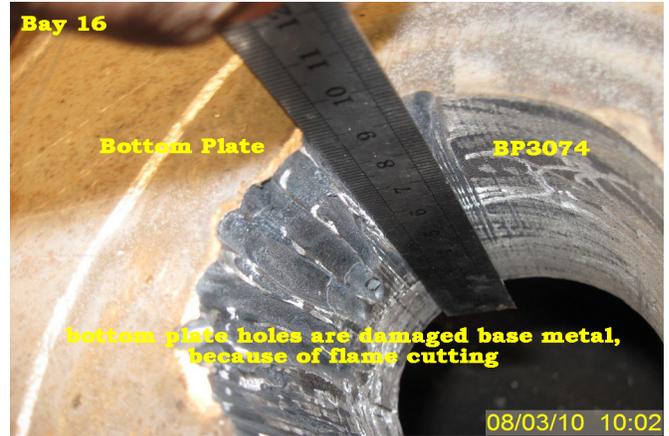
Visual Inspection Details: During random Quality Assurance Visual review of holes located on OBG Segment 13AW Bottom Plate, , this Quality Assurance Inspector (QA) discovered bottom plate 20 holes are damaged base metal, because of flame cutting; repair bottom plate is identified as BP3074. The weld repair holes are clearly marked on the material near the holes. The bottom plate is identified as SPCM. See the attached pictures
