**DEPARTMENT OF TRANSPORTATION**

Contract #: 04-0120F4Cty: SF/ALA Rte: 80 PM: 13.2/13.9File #: 99.28**WELDING INSPECTION REPORT****Resident Engineer:** Pursell, Gary**Address:** 333 Burma Road**City:** Oakland, CA 94607**Report No:** WIR-016199**Date Inspected:** 08-Aug-2010**Project Name:** SAS Superstructure**OSM Arrival Time:** 700**Prime Contractor:** American Bridge/Fluor Enterprises, a JV**OSM Departure Time:** 1900**Contractor:** Zhenhua Port Machinery Company, Ltd (ZPMC) Chanxing Island**Location:** Shanghai, China

# WELDING INSPECTION REPORT

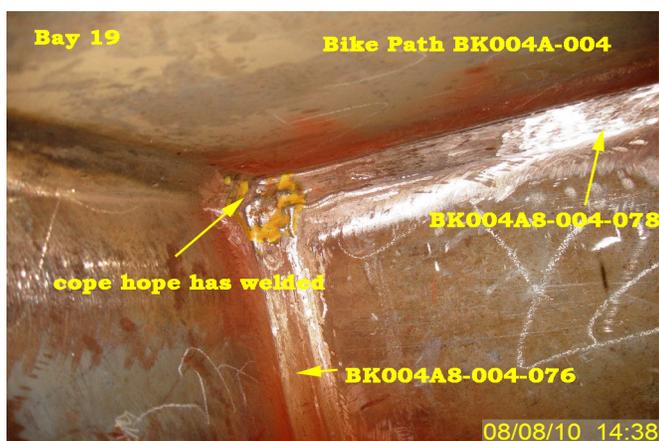
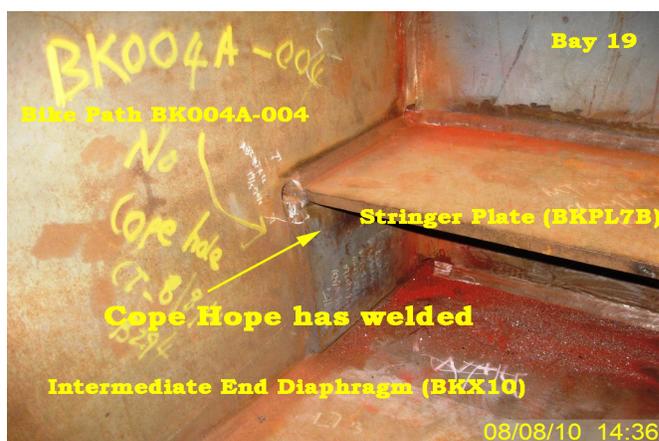
Description of Incident: During the Quality Assurance Magnetic Particle inspection on Bike Path at Bay 19, this Caltrans Quality Assurance (QA) Inspector observed that one cope hole/snipe has been welded shut on bike path identified as BK004A-004. The approved shop drawing specifies a cope hole/snipe located at the intersection of stringer plate BKPL7B and intermediate end diaphragm BKX10. A cope hole/snipe is specified at the end of welds identified as BK004A8-004-078 and BK004A8-004-076. This Bike Path is located in the west side of Bay 19. See the attached pictures.
