DEPARTMENT OF TRANSPORTATION

Contract #: 04-0120F4Cty: SF/ALA Rte: 80 PM: 13.2/13.9File #: 69.28**WELDING INSPECTION REPORT****Resident Engineer:** Pursell, Gary**Address:** 333 Burma Road**City:** Oakland, CA 94607**Report No:** WIR-016312**Date Inspected:** 11-Aug-2010**Project Name:** SAS Superstructure**OSM Arrival Time:** 1900**Prime Contractor:** American Bridge/Fluor Enterprises, a JV**OSM Departure Time:** 700**Contractor:** Zhenhua Port Machinery Company, Ltd (ZPMC), Changxing Island **Location:** Shanghai, China**CWI Name:** See Below**CWI Present:** Yes No**Inspected CWI report:** Yes No N/A**Rod Oven in Use:** Yes No N/A**Electrode to specification:** Yes No N/A**Weld Procedures Followed:** Yes No N/A**Qualified Welders:** Yes No N/A**Verified Joint Fit-up:** Yes No N/A**Approved Drawings:** Yes No N/A**Approved WPS:** Yes No N/A**Delayed / Cancelled:** Yes No N/A**Bridge No:** 34-0006**Component:** OBG and Tower**Summary of Items Observed:**

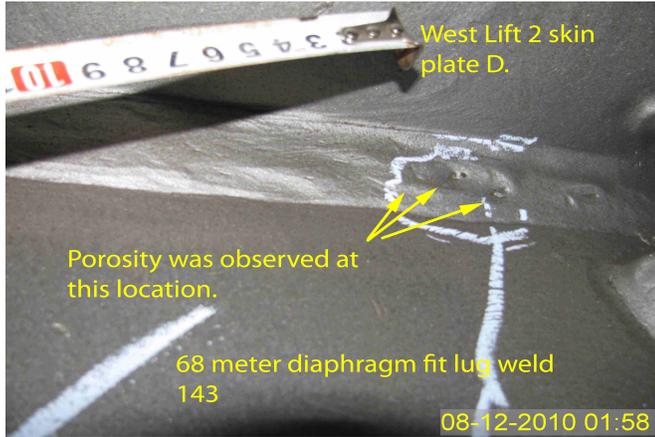
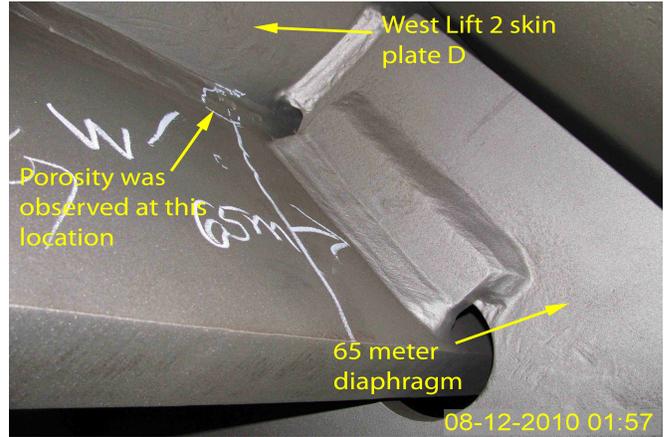
inspections of these areas. ABF and ZPMC Inspectors performed visual inspections of the areas indicated above and this QA Inspector visually observed approximately 50 locations that required grinding to resolve visual weld spatter, arc strikes, shallow nicks, scrapes, and other minor surface rejections and one area of porosity that will require weld repairs. These weld repair area was covered by gray duct tape. ZPMC and ABF personnel had not identified this area as being visually rejectable an incident report was issued as requested by Caltrop management. See the photographs below for additional information.
