DEPARTMENT OF TRANSPORTATION

Contract #: 04-0120F4Cty: SF/Ala Rte: 80 PM: 13.2/13.9File #: 69.28**WELDING INSPECTION REPORT****Resident Engineer:** Pursell, Gary**Address:** 333 Burma Road**City:** Oakland, CA 94607**Report No:** WIR-016324**Date Inspected:** 11-Aug-2010**Project Name:** SAS Superstructure**OSM Arrival Time:** 1900**Prime Contractor:** American Bridge/Fluor Enterprises, a JV**OSM Departure Time:** 700**Contractor:** Zhenhua Port Machinery Company, Ltd (ZPMC), Changxing Island **Location:** Shanghai, China**CWI Name:** See below**CWI Present:** Yes No**Inspected CWI report:** Yes No N/A**Rod Oven in Use:** Yes No N/A**Electrode to specification:** Yes No N/A**Weld Procedures Followed:** Yes No N/A**Qualified Welders:** Yes No N/A**Verified Joint Fit-up:** Yes No N/A**Approved Drawings:** Yes No N/A**Approved WPS:** Yes No N/A**Delayed / Cancelled:** Yes No N/A**Bridge No:** 34-0006**Component:** Tower Components**Summary of Items Observed:**

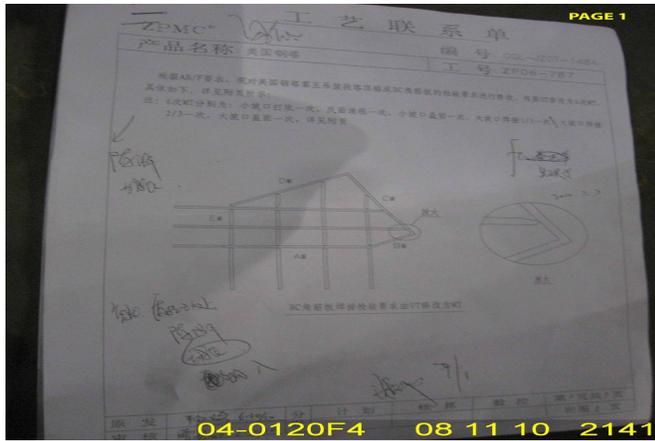
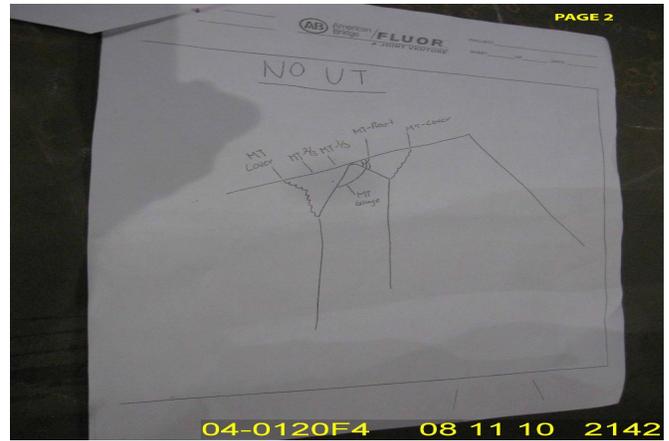
Alternating welders were identified as 066413, 067656, 066416. QC was identified at QC1. Assisting QC1 at this location and appearing to be monitoring the welding and recording data was QCA2, who was not a CWI. Welding variables recorded by QCA2 appeared to comply with WPS-B-T-3213-TC-U5b. This welding was being performed on the back side of weld NSD1-TL5-3B-F-12. The weld map shows that joint to be a weld detail WT253 which is a CJP with backing bar and uses WPS-B-T-3213-TC-U4c. The QC1 informed this QA Inspector that ZPMC has changed that weld configuration by gouging the back side, which was designed for a backing bar, and now was welding that joint per WPS-B-T-3213-U5b, which gets backgouged and welded on the backside. QC1 also informed this QA Inspector that the weld on the back side of NSD1-TL5-3B-F-12 had been assigned the new weld number NSD1-TL5-3B-F-80. The CWI produced a document which appears to be related only to the NDT of that joint. See photos of that two page document below.
