DEPARTMENT OF TRANSPORTATION

Contract #: 04-0120F4Cty: SF/ALA Rte: 80 PM: 13.2/13.9File #: 99.28**WELDING INSPECTION REPORT****Resident Engineer:** Pursell, Gary**Address:** 333 Burma Road**City:** Oakland, CA 94607**Report No:** WIR-016413**Date Inspected:** 17-Aug-2010**Project Name:** SAS Superstructure**OSM Arrival Time:** 700**Prime Contractor:** American Bridge/Fluor Enterprises, a JV**OSM Departure Time:** 1900**Contractor:** Zhenhua Port Machinery Company, Ltd (ZPMC) Chanxing Island**Location:** Shanghai, China

Bridge No: 34-0006**Component:** OBG Segments 11CW**Summary of Items Observed:**

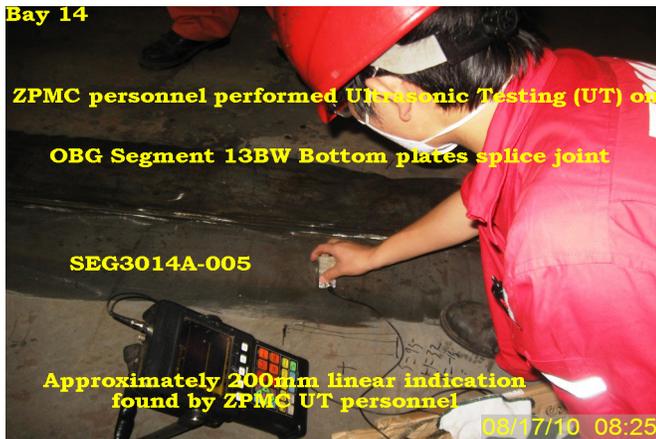
This QA inspector observed ZPMC personnel performed Ultrasonic Testing (UT) on OBG Segment 13BW Bottom plate splice joint, weld joint is identified as SEG3014A-005. See the attached picture.
