DEPARTMENT OF TRANSPORTATION

Contract #: 04-0120F4Cty: SF/ALA Rte: 80 PM: 13.2/13.9File #: 69.28**WELDING INSPECTION REPORT****Resident Engineer:** Pursell, Gary**Address:** 333 Burma Road**City:** Oakland, CA 94607**Report No:** WIR-016517**Date Inspected:** 26-Aug-2010**Project Name:** SAS Superstructure**OSM Arrival Time:** 700**Prime Contractor:** American Bridge/Fluor Enterprises, a JV**OSM Departure Time:** 1900**Contractor:** Zhenhua Port Machinery Company, Ltd (ZPMC), Changxing Island **Location:** Shanghai, China**CWI Name:** Xu Le Feng**CWI Present:** Yes No**Inspected CWI report:** Yes No N/A**Rod Oven in Use:** Yes No N/A**Electrode to specification:** Yes No N/A**Weld Procedures Followed:** Yes No N/A**Qualified Welders:** Yes No N/A**Verified Joint Fit-up:** Yes No N/A**Approved Drawings:** Yes No N/A**Approved WPS:** Yes No N/A**Delayed / Cancelled:** Yes No N/A**Bridge No:** 34-0006**Component:** Tower & OBG Components**Summary of Items Observed:**

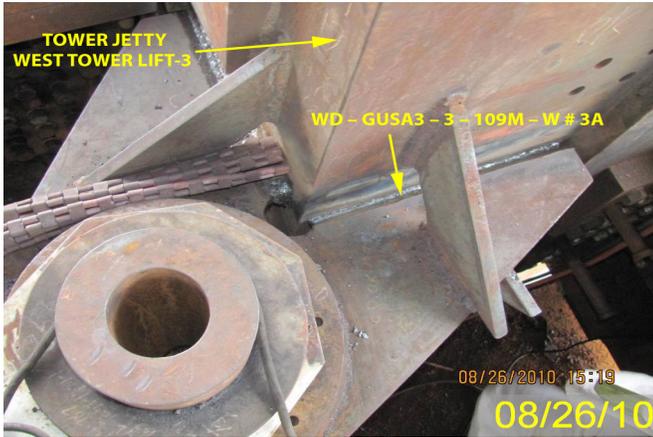
Weld joint # 3A located on West tower Lift-3 cross bracing gusset plate WD – GUSA3 – 3 – 109M – W. Welder is identified as 040690. ZPMC Quality Control (QC) Inspector is identified Zhao Chen Sun. The welding variables recorded by QC appeared to comply with the WPS – B – P – 2212 – Tc – U5b – FCM.
