DEPARTMENT OF TRANSPORTATION

Office of Structural Materials

Contract #: 04-0120F4Cty: SF/ALA Rte: 80 PM: 13.2/13.9File #: 69.28**WELDING INSPECTION REPORT****Resident Engineer:** Siegenthaler, Peter**Address:** 333 Burma Road**City:** Oakland, CA 94607**Report No:** WIR-017433**Date Inspected:** 27-Sep-2010**Project Name:** SAS Superstructure**OSM Arrival Time:** 700**Prime Contractor:** American Bridge/Fluor Enterprises, a JV**OSM Departure Time:** 1900**Contractor:** Zhenhua Port Machinery Company, Ltd (ZPMC), Changxing Island **Location:** Shanghai, China

Bridge No: 34-0006**Component:** Tower & OBG Components**Summary of Items Observed:**

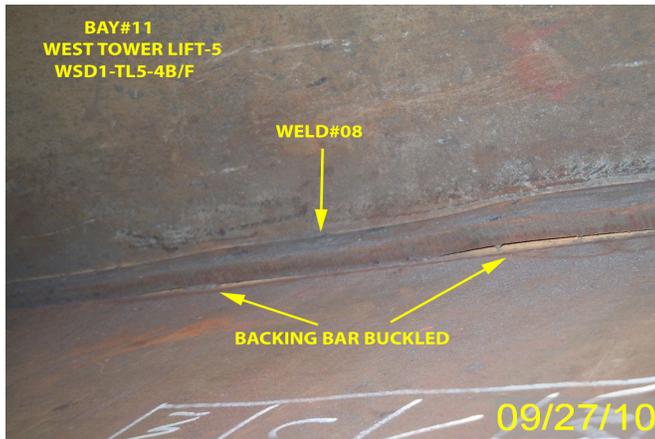
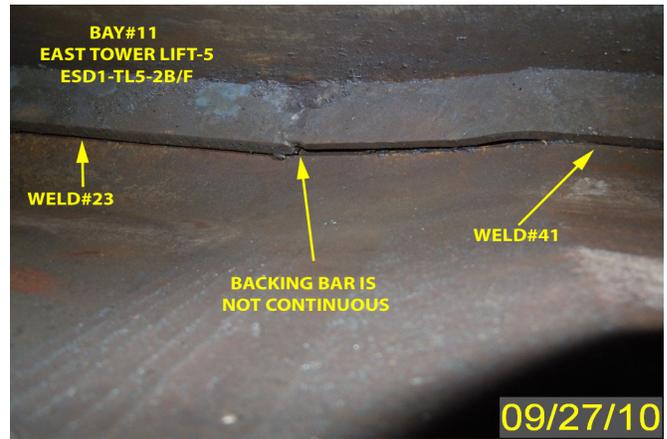
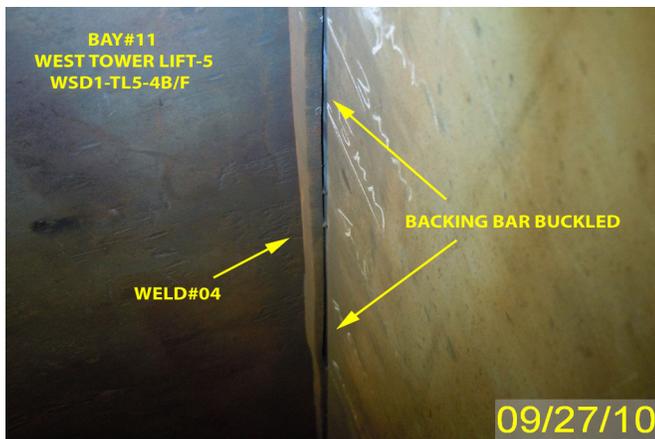
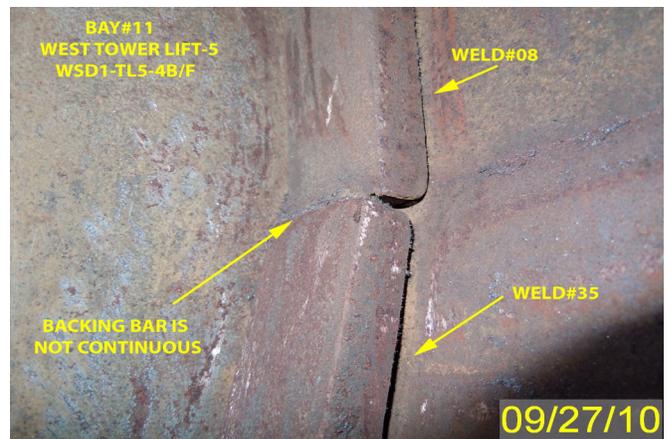
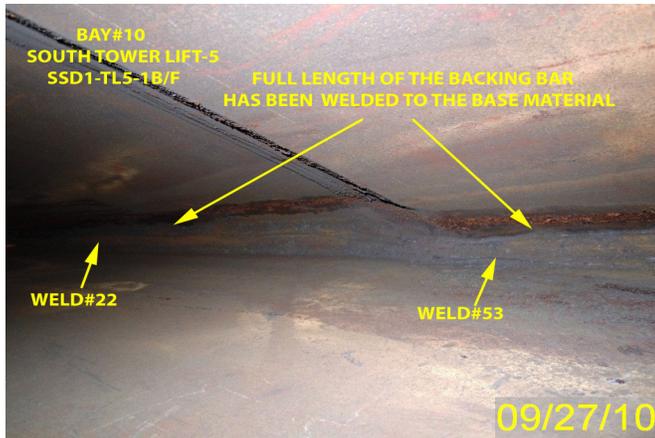
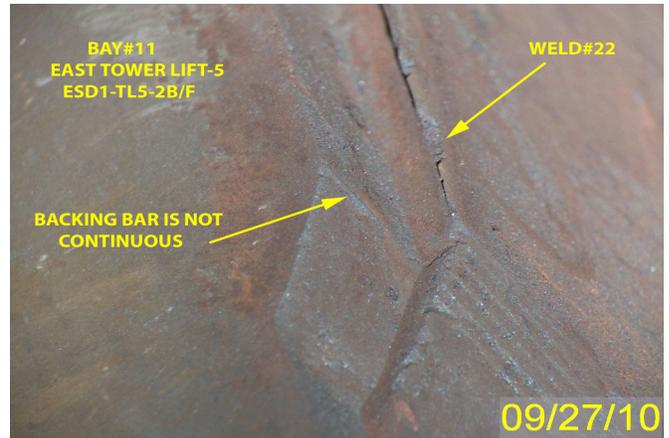
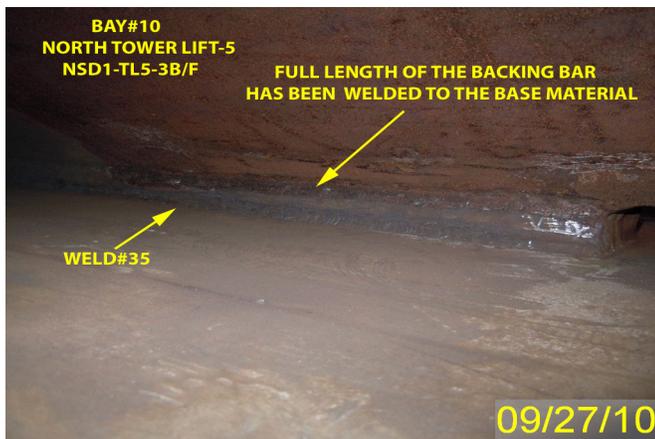
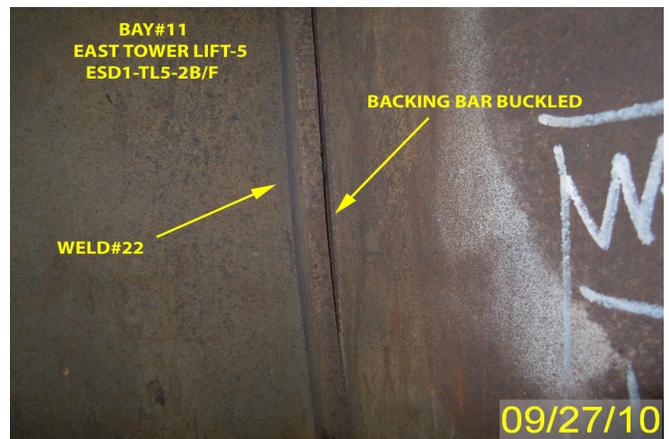
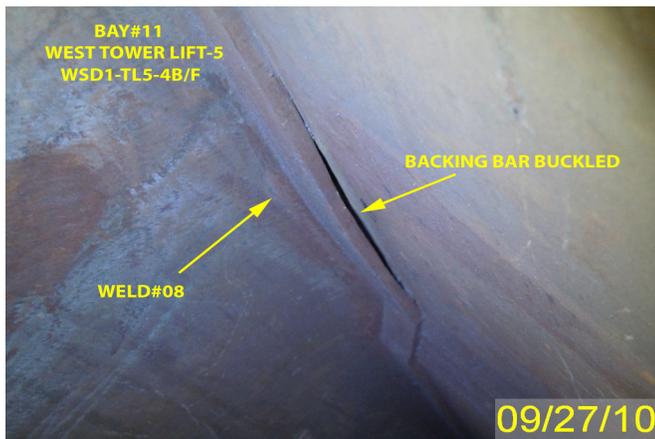
BACKING BAR SURVEY ON LIFT-5 TOWER SHAFTS AT BAY#10 & 11

During survey the following issues were discovered on lift-5 tower shafts: -

EAST TOWER LIFT-5: (ESD1 – TL5 – 2B-F)

1. Backing bar is not continuous between the welds (WELD#22 & 42) and buckled (WELD#22)
2. Backing bar is not continuous between the welds (WELD#23 & 41)

WEST TOWER LIFT-5: (WSD1 – TL5 – 4B-F)

1. Backing bar buckled at 2 different locations (WELD#04)
2. Backing bar is not continuous between the welds and buckled at 3 different locations (WSD1-TL5-4B-F#08&35)

SOUTH TOWER LIFT-5: At 9 different locations backing bar has been continuously welded full length of the weld with the base material.

NORTH TOWER LIFT-5: At 9 different locations backing bar has been continuously welded full length of the weld with the base material.

For further information see attached pictures:
