**DEPARTMENT OF TRANSPORTATION**

Contract #: 04-0120F4Cty: SF/ALA Rte: 80 PM: 13.2/13.9File #: 69.28**WELDING INSPECTION REPORT****Resident Engineer:** Siegenthaler, Peter**Address:** 333 Burma Road**City:** Oakland, CA 94607**Report No:** WIR-017538**Date Inspected:** 11-Oct-2010**Project Name:** SAS Superstructure**OSM Arrival Time:** 700**Prime Contractor:** American Bridge/Fluor Enterprises, a JV**OSM Departure Time:** 1900**Contractor:** Zhenhua Port Machinery Company, Ltd (ZPMC), Changxing Island **Location:** Shanghai, China**CWI Name:** Xu Le Feng**CWI Present:** Yes No**Inspected CWI report:** Yes No N/A**Rod Oven in Use:** Yes No N/A**Electrode to specification:** Yes No N/A**Weld Procedures Followed:** Yes No N/A**Qualified Welders:** Yes No N/A**Verified Joint Fit-up:** Yes No N/A**Approved Drawings:** Yes No N/A**Approved WPS:** Yes No N/A**Delayed / Cancelled:** Yes No N/A**Bridge No:** 34-0006**Component:** Tower & OBG Components**Summary of Items Observed:**

## WELDING INSPECTION REPORT

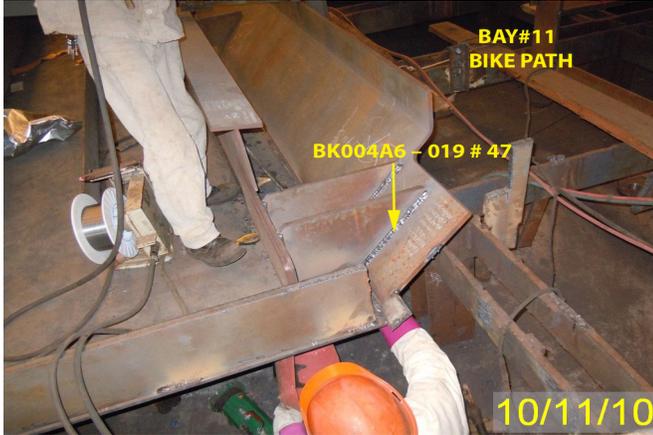
Weld joint # 047 located on Bike Path BK004A6 – 019. Welder is identified as 053316. ZPMC Quality Control (QC) Inspector is identified as Yu Dong ping. The welding variables recorded by QC appeared to comply with the WPS – B – T – 2133. (See attached photo)

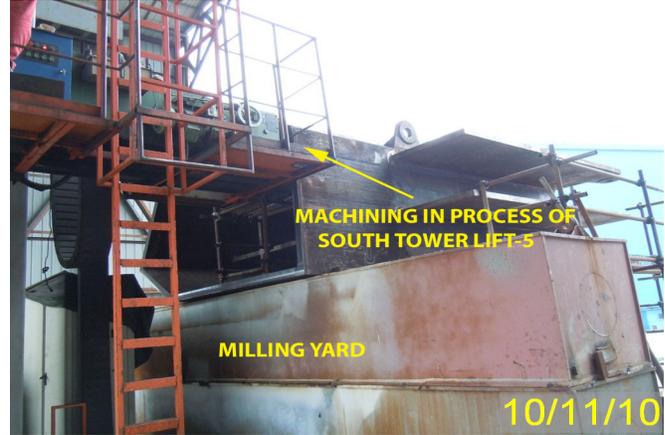
ZPMC performed machining for south tower lift-5 prior completion of 100% NDT (Ultrasonic Testing) on following grillage weld designations:

SD1-TL5-1B/F-53 &22 (SKIN D/E CORNER WELDS)  
(See attached picture)
