DEPARTMENT OF TRANSPORTATION

Quality Assurance and Source Inspection

Contract #: 04-0120F4Cty: SF/ALA Rte: 80 PM: 13.2/13.9File #: 69.28**WELDING INSPECTION REPORT****Resident Engineer:**Siegenthaler, Peter**Address:** 333 Burma Road**City:** Oakland, CA 94607**Report No:** WIR-017562**Date Inspected:** 18-Oct-2010**Project Name:** SAS Superstructure**OSM Arrival Time:** 700**Prime Contractor:** American Bridge/Fluor Enterprises, a JV**OSM Departure Time:** 1900**Contractor:** Zhenhua Port Machinery Company, Ltd (ZPMC), Changxing Island **Location:** Shanghai, China**CWI Name:** Mr. Yu Dong Ping**CWI Present:** Yes No**Inspected CWI report:** Yes No N/A**Rod Oven in Use:** Yes No N/A**Electrode to specification:** Yes No N/A**Weld Procedures Followed:** Yes No N/A**Qualified Welders:** Yes No N/A**Verified Joint Fit-up:** Yes No N/A**Approved Drawings:** Yes No N/A**Approved WPS:** Yes No N/A**Delayed / Cancelled:** Yes No N/A**Bridge No:** 34-0006**Component:** Tower**Summary of Items Observed:**

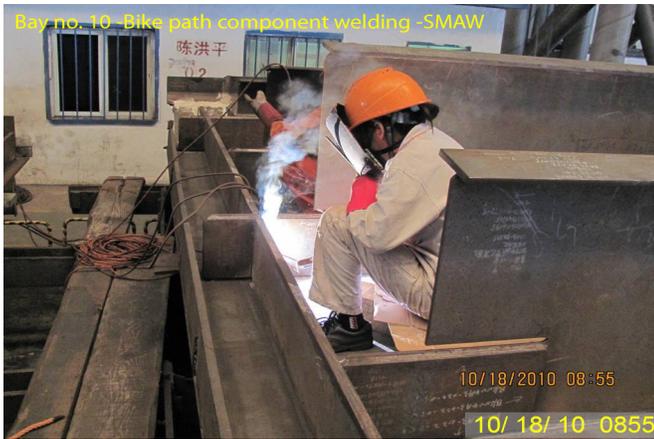
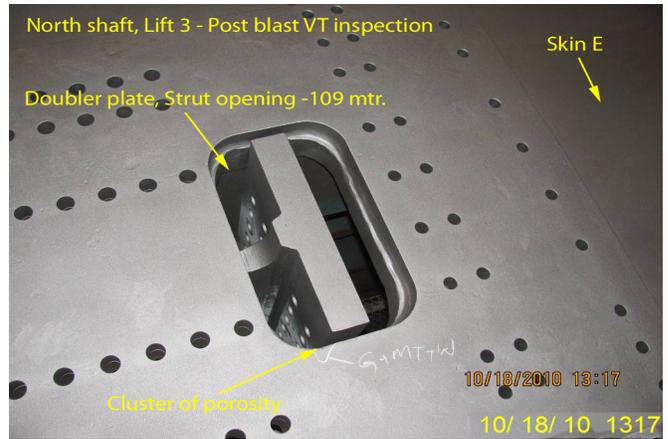
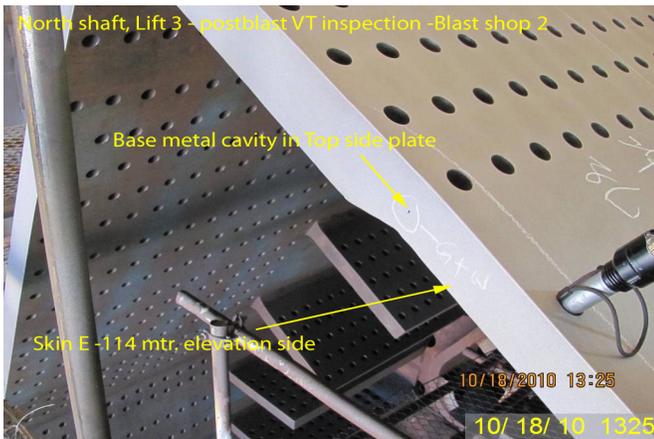
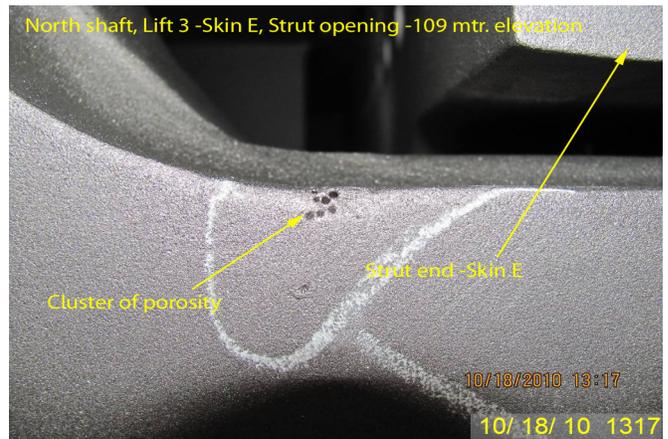
This QA inspector, Baskar Govindarajan, performed Post blast Visual inspection of external surfaces of North tower, Lift 3. All the areas marked which requires grinding, weld repair, Grinding & MT wherever applicable in all the Skins of Tower from 83 to 114 mtr. Elevation. This inspection was carried out along with QA Inspector Mr. Gade (B 307), Mr. Shailesh (B 295), Mr. Sandeep (B 227), and Mr. Art Peterson (B 273). All the marked points shown to ZPMC inspector Mr. Zhao Chen Sun and ABF Inspector Mr. Kim. All the weld repair areas (2 nos) marked in weld map in detail and the same was signed by ZPMC and ABF Inspector. Incident report rose for the same.

For further information see below pictures:-
