**DEPARTMENT OF TRANSPORTATION**

Contract #: 04-0120F4Cty: SF/ALA Rte: 80 PM: 13.2/13.9File #: 69.28**WELDING INSPECTION REPORT****Resident Engineer:** Siegenthaler, Peter**Address:** 333 Burma Road**City:** Oakland, CA 94607**Report No:** WIR-017570**Date Inspected:** 25-Oct-2010**Project Name:** SAS Superstructure**OSM Arrival Time:** 1900**Prime Contractor:** American Bridge/Fluor Enterprises, a JV**OSM Departure Time:** 700**Contractor:** Zhenhua Port Machinery Company, Ltd (ZPMC), Changxing Island **Location:** Shanghai, China**CWI Name:** Mr. Xu Tao**CWI Present:** Yes No**Inspected CWI report:** Yes No N/A**Rod Oven in Use:** Yes No N/A**Electrode to specification:** Yes No N/A**Weld Procedures Followed:** Yes No N/A**Qualified Welders:** Yes No N/A**Verified Joint Fit-up:** Yes No N/A**Approved Drawings:** Yes No N/A**Approved WPS:** Yes No N/A**Delayed / Cancelled:** Yes No N/A**Bridge No:** 34-0006**Component:** OBG**Summary of Items Observed:**

# WELDING INSPECTION REPORT

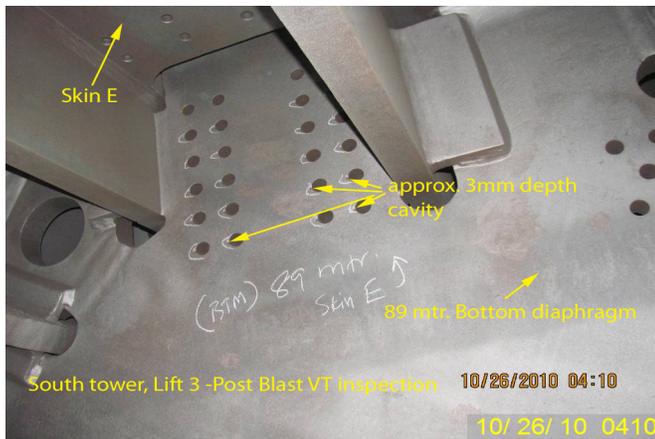
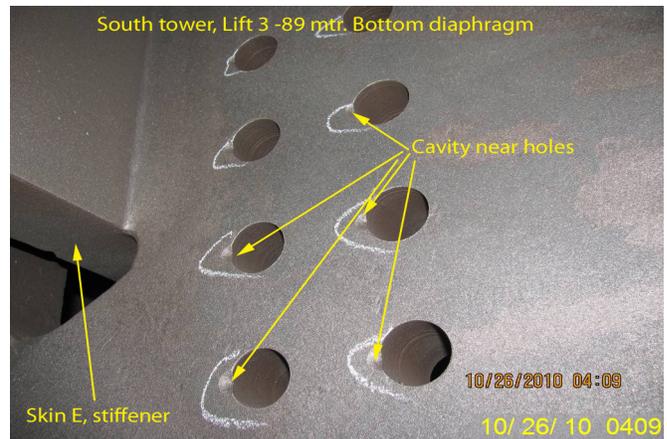
This QA inspector, Baskar Govindarajan, performed Post blast Visual inspection of internal surfaces of South

tower, Lift 3. All the areas marked which requires grinding, weld repair, Grinding & MT wherever applicable in all the Skins of Tower from 83 to 99 mtr. Top Diaphragm. This inspection was carried out along with QA Inspector Mr. George Goulet (B. 218) and Mr. Kelly Leavitt . All the marked points shown to ZPMC inspector Mr. Sun Zhi Wang and ABF Inspector Mr. Wang Jiang Hua. All the weld repair area (1 no) marked in weld map in detail and the same was signed by ZPMC and ABF Inspector. This repair found in 89 mtr. Bottom diaphragm, Skin E, Drilled holes. Blast inspection report rose for the same.
