DEPARTMENT OF TRANSPORTATION

Quality Assurance and Source Inspection

Contract #: 04-0120F4Cty: SF/ALA Rte: 80 PM: 13.2/13.9File #: 99.28**WELDING INSPECTION REPORT****Resident Engineer:** Siegenthaler, Peter**Address:** 333 Burma Road**City:** Oakland, CA 94607**Report No:** WIR-017645**Date Inspected:** 29-Oct-2010**Project Name:** SAS Superstructure**OSM Arrival Time:** 700**Prime Contractor:** American Bridge/Fluor Enterprises, a JV**OSM Departure Time:** 1900**Contractor:** Zhenhua Port Machinery Company, Ltd (ZPMC)**Location:** Shanghai, China**CWI Name:** Li Yang and Zhu Zhong Hai**CWI Present:** Yes No**Inspected CWI report:** Yes No N/A**Rod Oven in Use:** Yes No N/A**Electrode to specification:** Yes No N/A**Weld Procedures Followed:** Yes No N/A**Qualified Welders:** Yes No N/A**Verified Joint Fit-up:** Yes No N/A**Approved Drawings:** Yes No N/A**Approved WPS:** Yes No N/A**Delayed / Cancelled:** Yes No N/A**Bridge No:** 34-0006**Component:** OBG Trial Assembly**Summary of Items Observed:**

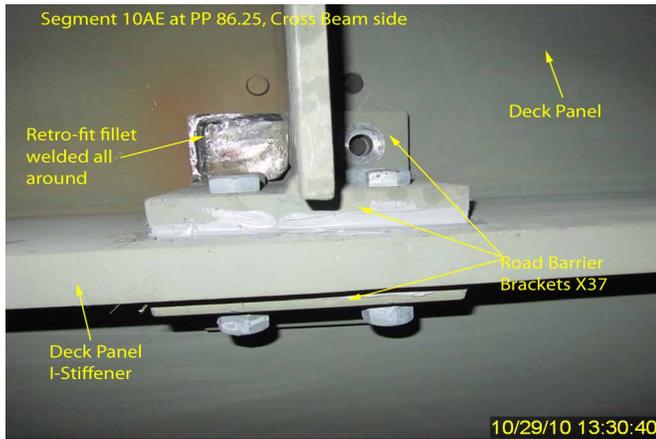
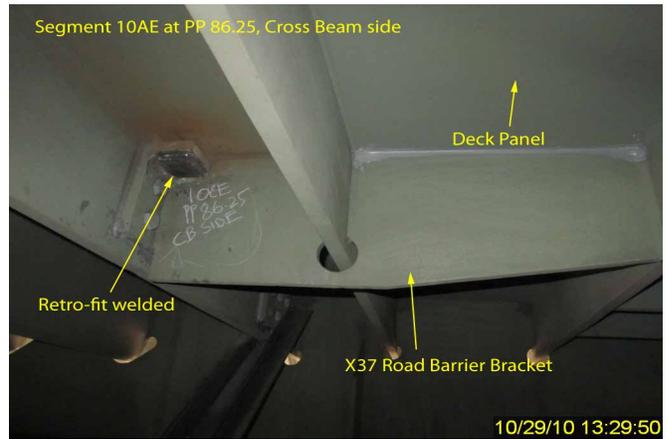
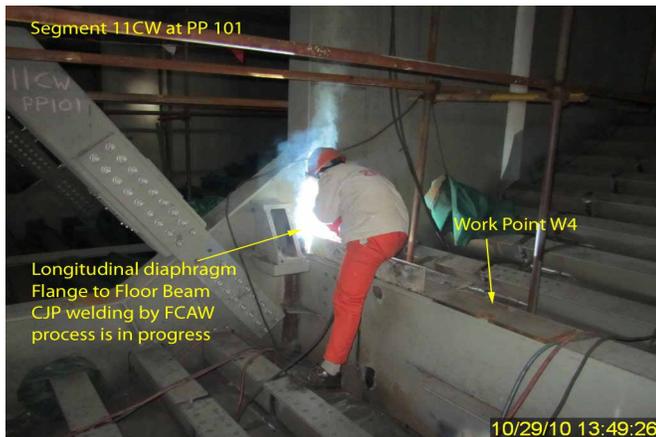
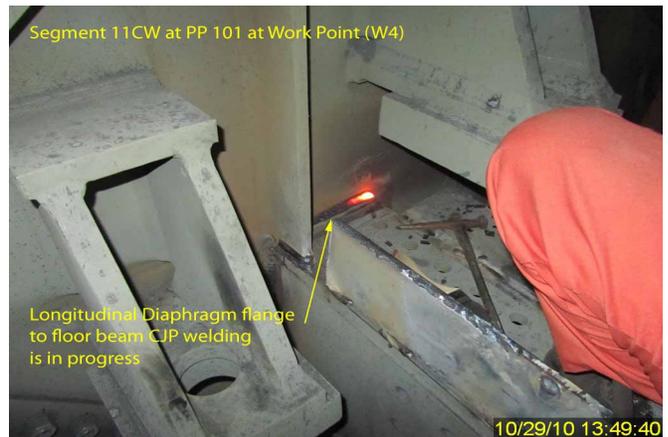
This QA Inspector performed Dimension Control Inspection on October 23, 2010 for the Segment 10AE, Segment 10BE and Segment 10CE. Measured the distance between road barrier bolt hole drilled at X37B from deck panel to the cope hole at X37B bracket installed at Corner Assembly at east and west side of the X37B brackets. Identified the locations where dimension is out of tolerance and needs retro-fits.

Visual inspection was performed as on date i.e., October 29, 2010 to verify the installation of retro-fits at following locations.
