DEPARTMENT OF TRANSPORTATION

Office of Structural Materials

Contract #: 04-0120F4Cty: SF/ALA Rte: 80 PM: 13.2/13.9File #: 69.28**WELDING INSPECTION REPORT****Resident Engineer:** Siegenthaler, Peter**Address:** 333 Burma Road**City:** Oakland, CA 94607**Report No:** WIR-017723**Date Inspected:** 21-Oct-2010**Project Name:** SAS Superstructure**OSM Arrival Time:** 700**Prime Contractor:** American Bridge/Fluor Enterprises, a JV**OSM Departure Time:** 1900**Contractor:** Zhenhua Port Machinery Company, Ltd (ZPMC), Changxing Island **Location:** Shanghai, China**CWI Name:** Qiu Wen**CWI Present:** Yes No**Inspected CWI report:** Yes No N/A**Rod Oven in Use:** Yes No N/A**Electrode to specification:** Yes No N/A**Weld Procedures Followed:** Yes No N/A**Qualified Welders:** Yes No N/A**Verified Joint Fit-up:** Yes No N/A**Approved Drawings:** Yes No N/A**Approved WPS:** Yes No N/A**Delayed / Cancelled:** Yes No N/A**Bridge No:** 34-0006**Component:** TOWER & OBG Components**Summary of Items Observed:**

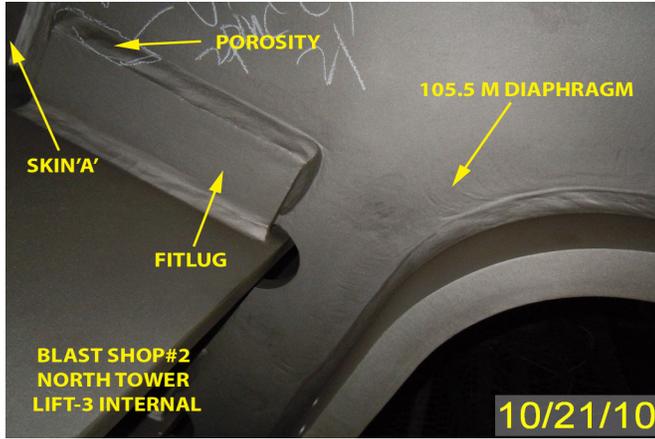
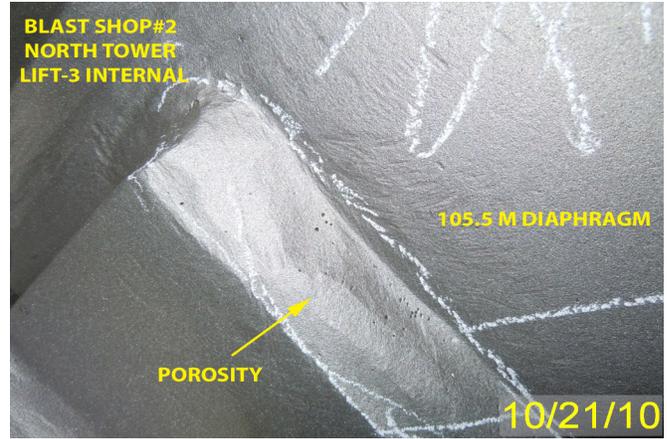
During the Internal pre-blast visual inspection on North tower Lift-3 from 102.5 M elevation to 111.67 M, this Quality Assurance Inspector (QA) discovered the defects required welding and Magnetic particle testing on weld at the following location:

1) Fit-lug to diaphragm weld – POROSITY –Skin ‘A’ 2nd stiffener from skin ‘E’ of 105.5 M diaphragm.
