Contract #: 04-0120F4Cty: SF/ALA Rte: 80 PM: 13.2/13.9File #: 99.28**WELDING INSPECTION REPORT****Resident Engineer:** Siegenthaler, Peter**Address:** 333 Burma Road**City:** Oakland, CA 94607**Report No:** WIR-017971**Date Inspected:** 30-Oct-2010**Project Name:** SAS Superstructure**OSM Arrival Time:** 700**Prime Contractor:** American Bridge/Fluor Enterprises, a JV**OSM Departure Time:** 1900**Contractor:** Zhenhua Port Machinery Company, Ltd (ZPMC) Chanxing Island**Location:** Shanghai, China**CWI Name:** Mr. Xu Tao**CWI Present:** Yes No**Inspected CWI report:** Yes No N/A**Rod Oven in Use:** Yes No N/A**Electrode to specification:** Yes No N/A**Weld Procedures Followed:** Yes No N/A**Qualified Welders:** Yes No N/A**Verified Joint Fit-up:** Yes No N/A**Approved Drawings:** Yes No N/A**Approved WPS:** Yes No N/A**Delayed / Cancelled:** Yes No N/A**Bridge No:** 34-0006**Component:** OBG Segment and Bike Path**Summary of Items Observed:**

WELDING INSPECTION REPORT

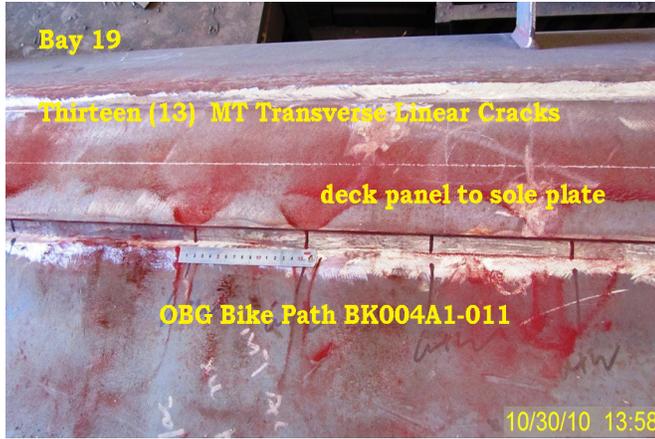
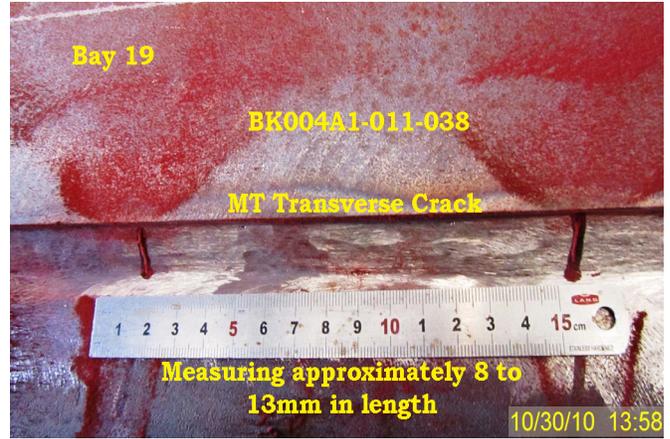
Description of Incident: During random Quality Assurance visual and work in progress of welds located on OBG Bike Path, ZPMC Quality Control Inspector (QC) discovered that Thirteen (13) Transverse Linear Cracks with each measuring approximately 8 to 13mm in length. The cracks were found on sole plate of bike path identified as BK004A1-011-038. The weld is fillet weld joint, joining the deck panel to sole plate, this plate are identified as non Seismic Performance Critical Member (non SPCM). The indications are clearly marked on the material near the weld. OBG Bike Path BK004A1-011 is located at Bay#19. The Caltrans (CT) Quality Assurance Inspector (QA) requested to ZPMC QC, to prepare Critical weld repair report (CWR) and perform weld repair on above mention weld. See the attached picture.
