**DEPARTMENT OF TRANSPORTATION**

Contract #: 04-0120F4Cty: SF/ALA Rte: 80 PM: 13.2/13.9File #: 69.28**WELDING INSPECTION REPORT****Resident Engineer:** Siegenthaler, Peter**Address:** 333 Burma Road**City:** Oakland, CA 94607**Report No:** WIR-018654**Date Inspected:** 24-Oct-2010**Project Name:** SAS Superstructure**OSM Arrival Time:** 1500**Prime Contractor:** American Bridge/Fluor Enterprises, a JV**OSM Departure Time:** 300**Contractor:** Zhenhua Port Machinery Company, Ltd (ZPMC), Changxing Island **Location:** ShangHai, China**CWI Name:** Tian Lei**CWI Present:** Yes No**Inspected CWI report:** Yes No N/A**Rod Oven in Use:** Yes No N/A**Electrode to specification:** Yes No N/A**Weld Procedures Followed:** Yes No N/A**Qualified Welders:** Yes No N/A**Verified Joint Fit-up:** Yes No N/A**Approved Drawings:** Yes No N/A**Approved WPS:** Yes No N/A**Delayed / Cancelled:** Yes No N/A**Bridge No:** 34-0006**Component:** OBG**Summary of Items Observed:**

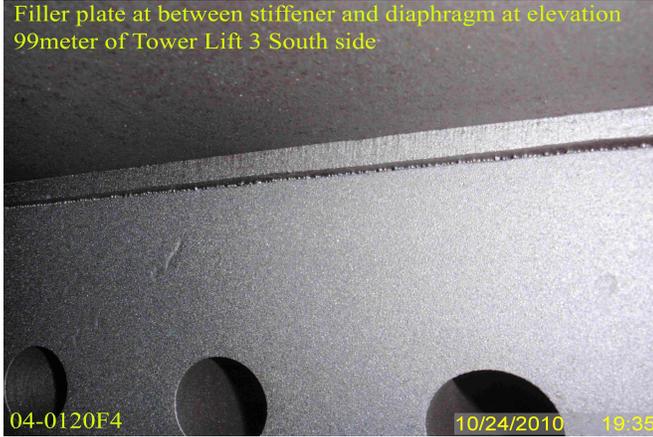
QA inspector has performed visual inspection on interior of elevation 83 meter to 99 meter of Tower Lift 3 South side, QA inspector has find out 2 grind plus MT and 4 places to use filler Plate for filled gap between stiffener plate to diaphragm connection.

Filler plate at between stiffener and diaphragm at elevation 99meter of Tower Lift 3 South side

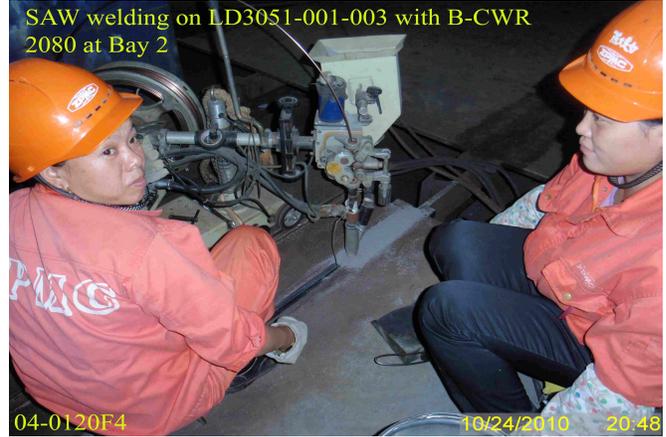
SAW welding on LD3051-001-003 with B-CWR 2080 at Bay 2
